Moscow, 6-8. 09. 2011

International conference  
**EngeoPro-2011**

## THE MW=9.0 TOHOKU JAPAN EARTHQUAKE (MARCH 11, 2011) TSUNAMI IMPACT ON STRUCTURES AND INFRASTRUCTURE

**E. Lekkas, E. Andreidakis, V. Alexoudi, E. Kapourani, I. Kostaki**

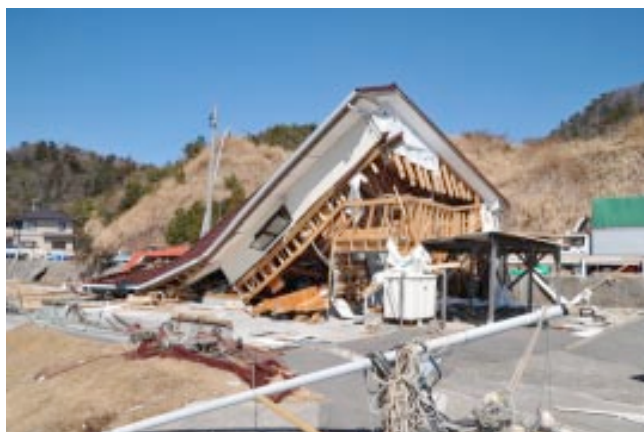
On the contrary, the tsunami impact was devastating. More specifically, they were totally swept by the wave forces and by the impact of objects carried by the water. They were broken to small pieces of debris,

which were deposited in the inundated areas, or were carried to the cost-line or the open sea, when the water receded. A great number of this particular type of constructions were swept by their footings and were carried, practically unchanged, to great distances (Fig. 2, 3, 4).

**Fig.2.** Collapse of a wood frame house in Iwaki area. Tsunami height of about 5 m

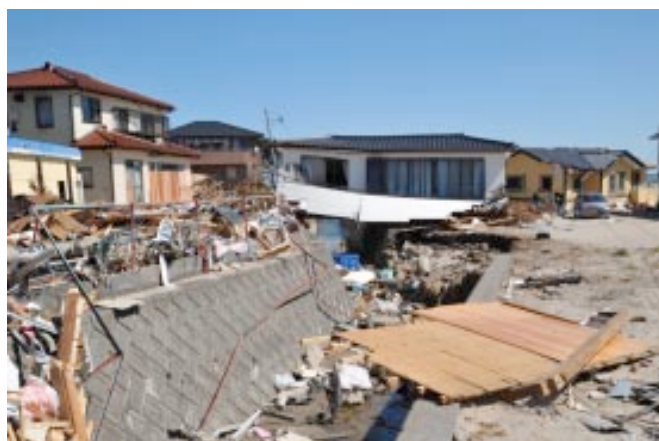
**Fig.3.** Of a wood frame residential construction and collapse of others, in Iwaki area

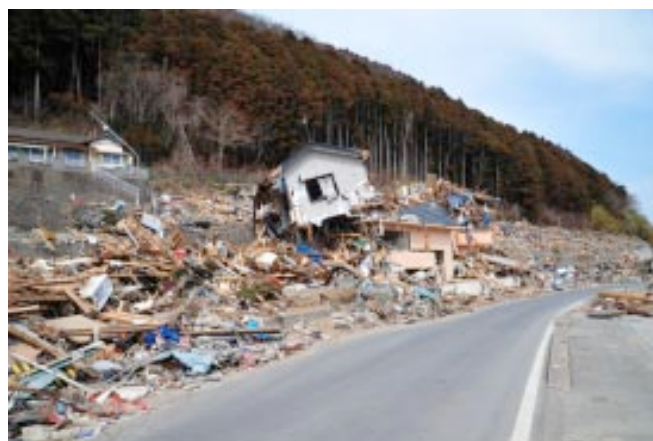
**Fig.4.** Transport and collapse of wood frame constructions inn Onagawa city

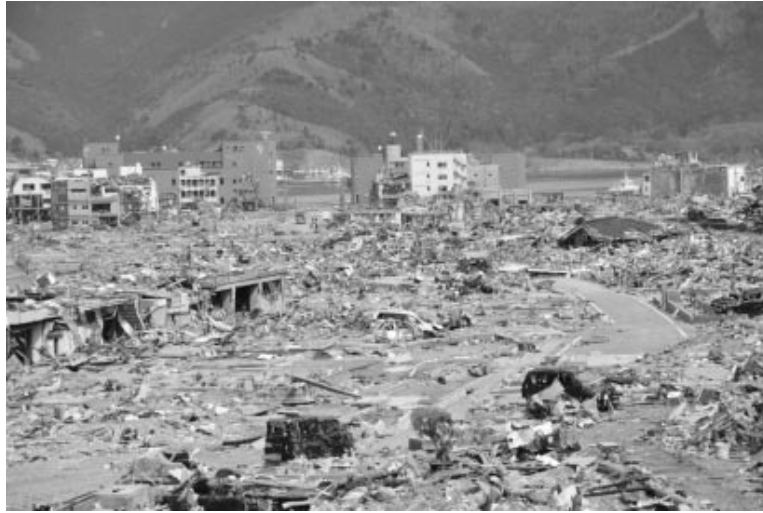
Damage to the engineered constructions was limited to broken doors and windows and masonry failures. Masonry walls suffered out of plane failures and were jettisoned in great distance, mainly in buildings constructed near the shoreline. No damage on the supporting structure caused by the tsunami was observed (Fig.5). Only in certain areas and isolated cases, minor damage to columns was observed, resulting from the impact of debris or objects carried by the water, such as cars and boats.

Upon coming to shore, as well as during recession, the tsunami waves were highly turbulent. This led to scouring of granular foundation material in some buildings (particularly those that were closest to the shoreline), resulting in loss of support and partial overturning or collapse.

**Fig. 5.** Total collapse of constructions in Onagawa area. Near the coast, engineered reinforced concrete constructions can be seen damaged but standing

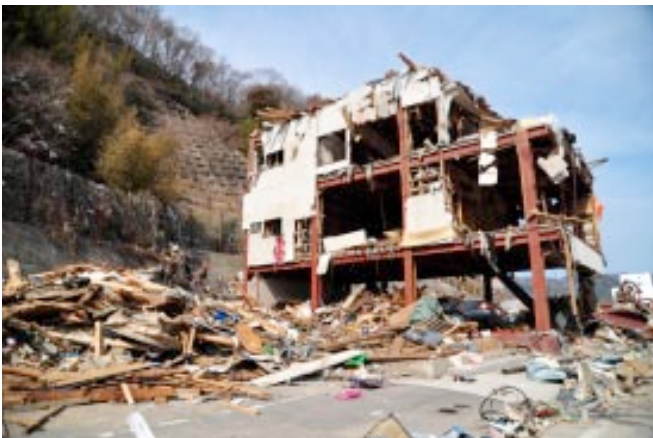
In contrast, the tsunami had important effects on these constructions, both in supporting and non-supporting elements. In most cases masonry walls out of plane punching shear failures were observed, due to tsunami lateral forces and the impact of debris carried by the water, up to the wave maximum run-up height in a given area. In many cases the steel frame buildings were left empty of all infill walls as well as flooring.

Many of these buildings, mainly those built near the shoreline, suffered great lateral loading on structural elements, resulting in a more or less general deformation of the structure. In some cases all of the steel elements were lifted from their reinforced concrete bases and were carried (totally deformed) in different areas. It should be noted that the masonry of the metal frame buildings proved to be much more vulnerable than that of the engineered reinforced concrete buildings (Fig.6, 7).

**Fig.6.** Masonry failures in steel frame building in Onagawa city

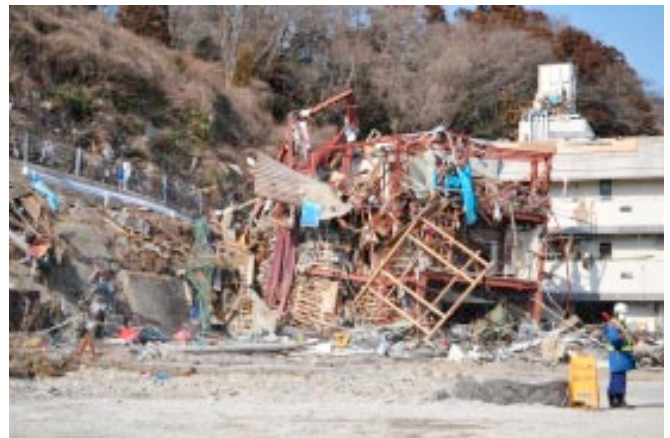
**Fig.7.** Total deformation of steel frame building elements in Onagawa city

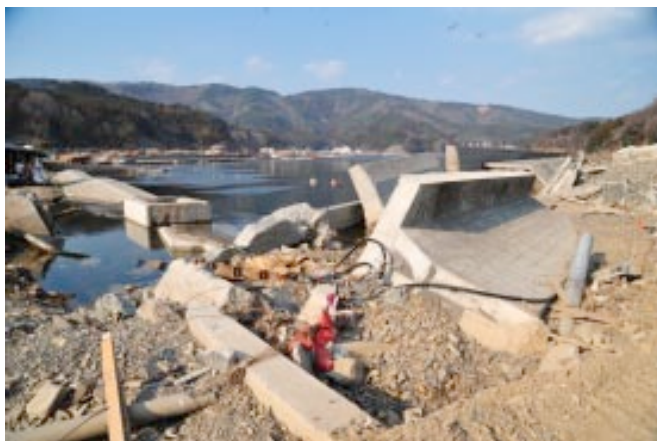
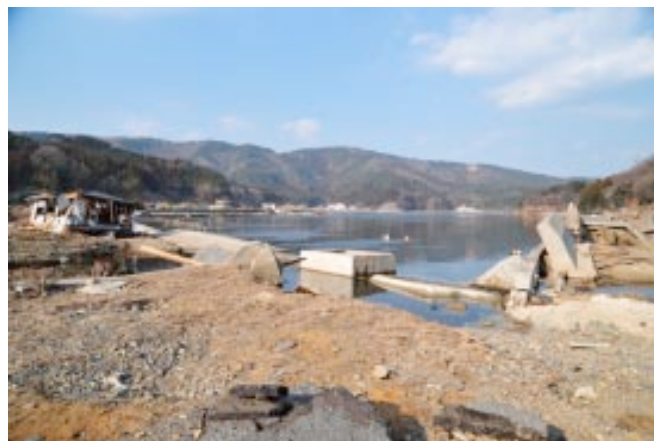
Specifically, failing and deformation of quay walls was observed, caused either by the hydrodynamic forces of the waves, or the impact of objects such as boats and containers.

In many cases the quay walls and the accompanying supporting constructions collapsed or were overturned, due to the intense scour of the foundation materials. Moreover, the seaport constructions proved to be especially vulnerable to receding waters, which caused intense deformation and overturning.

Finally, the piers constructed in order to protect against tsunami waves, could not cope with the observed tsunami, either because of inadequate or underestimated structural design, or because of collapse, resulting in devastating effects on inland areas. In addition, severe failures because of intense erosion were observed in levees and coastal river regulation constructions (Fig. 8, 9).

**Fig.8.** Destroyed port facilities and general alteration of the shoreline in Mizuhama town

**Fig.9.** Destroyed port facilities and general alteration of the shoreline in Mizuhama town

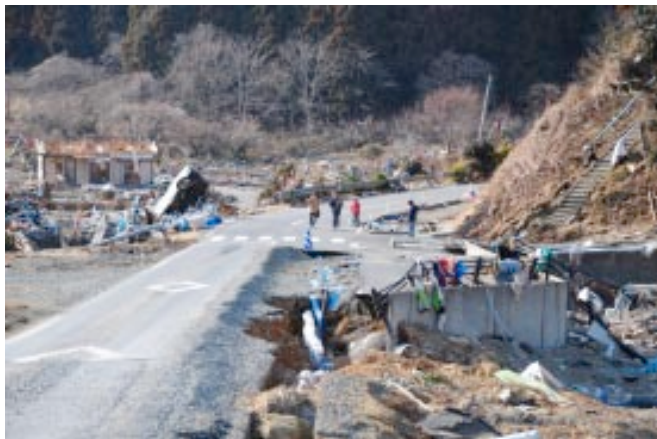
A large part of the coastal road network of the tsunami affected areas was totally destroyed, either by the waves themselves, or by debris impact. Damage was observed on the pavement, mainly caused by the erosion of the substrate material. There are also many cases in which the road deck was transferred in great distance, having suffered intense deformation (Fig.10).

**Fig. 10.** Intense erosion and destruction of road network in Ommaehema town

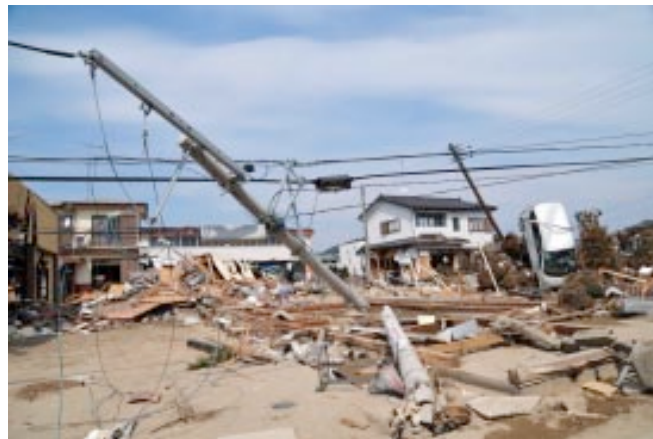
The power generation systems, telecommunication networks and mobile telephony towers were completely destroyed, resulting in the interruption of communications (Fig.11).

**Fig. 11.** Power distribution network damage in Isinomaki town
