Earthquake Resistant Engineering Structures

Adana Earthquake: Peculiar damage distribution and seismotectonic characteristics

Lekkas E. & Vassilakis E.

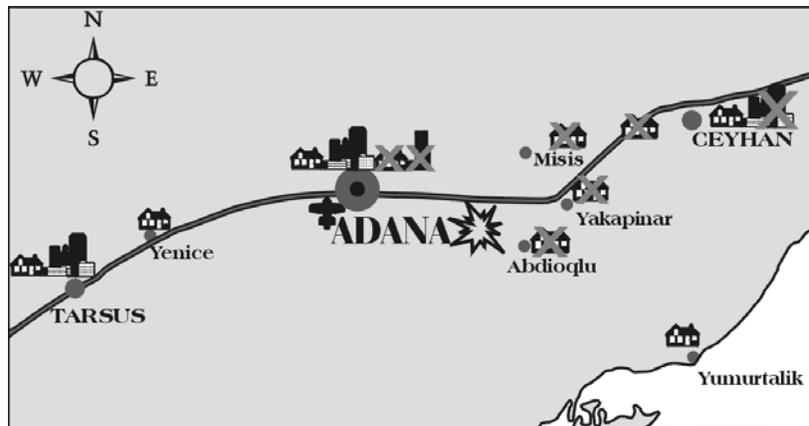
Figure 3. Compendious map of the damage distribution (X) and the type of it (tall buildings, old residential structures), after the main shock.

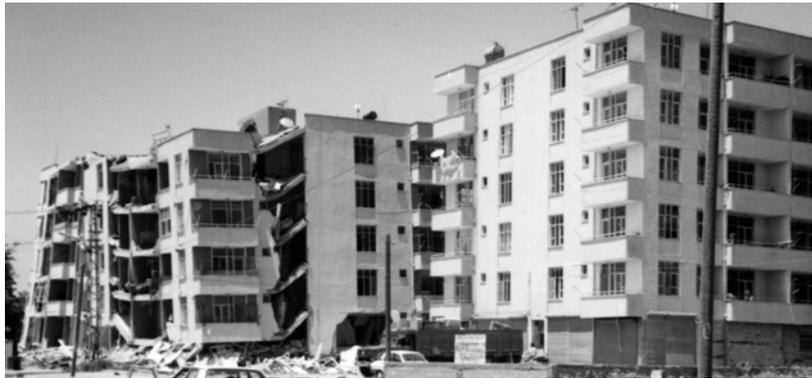
In the city of Ceyhan, only a small percentage of damages occurred in small old type structures, while the majority of these structures remained essentially undamaged. On the contrary, a significant number of multi-story buildings collapsed. They were of older age and located in the centre and the outskirts. Additionally, more than 30 modern buildings of 6-8 stories with earthquake-design standards collapsed or suffered significant damages (Figure 4).

and 0.086g (UP). The records show several dominant frequencies (periods) at approximately 0.7, 1, and 1.5 Hz (1.4, 1 and 0.67 sec) (Celebi[5]). These resonating frequencies are within the site frequencies that can be expected from alluvial media with depths ranging from 25-50 m. It is possible that double resonance was one of the main causes of collapses or severe damage in the mid-rise buildings in Ceyhan. Soil-structure interaction of the rather stiff buildings may have contributed to the lengthening of the buildings' periods to coincide with the dominant periods of the site. The response spectra demonstrate that the horizontal components of the motion had several dominant peaks within a 0.2-0.7 second band.

Figure 4. Aspect of the damages on modern constructions at the eastern sector of Ceyhan.

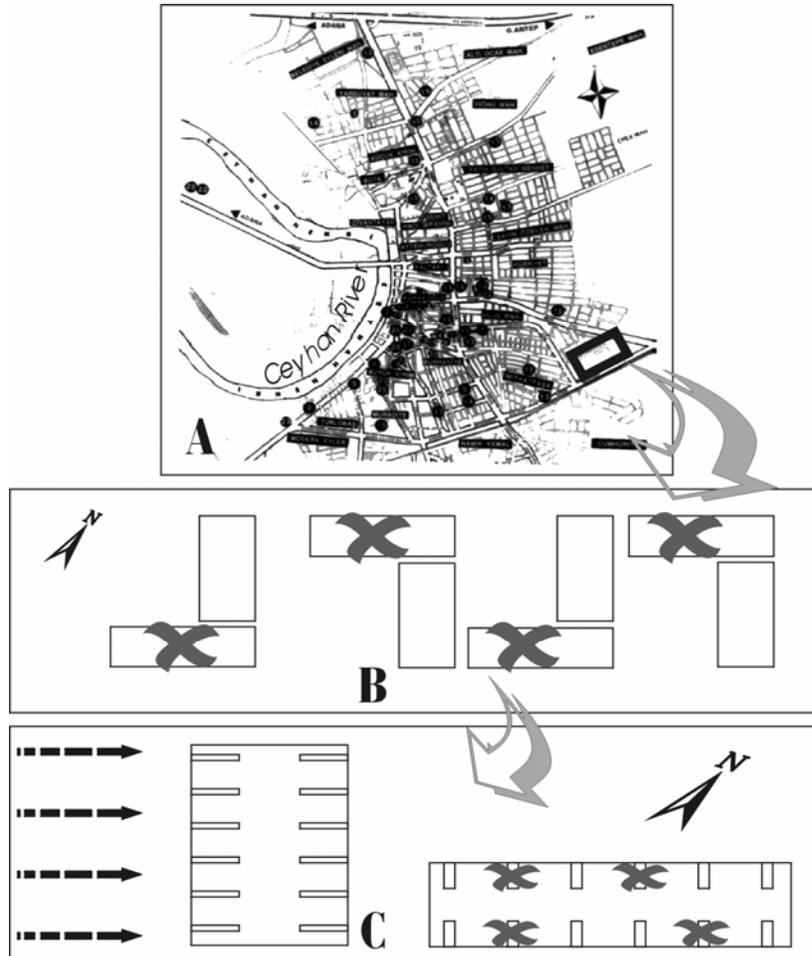
In the eastern part of Ceyhan, multi-story residential buildings have been constructed, which have a different orientation, although identical regarding the ground plans and the construction in general. In particular, two perpendicular orientations can be identified in the oblong ground plan: one running NE-SW and the second running NW-SE. The main characteristic of the aforementioned buildings is that almost all pillars had an oblong direction perpendicular to the oblong direction of the greater dimension of the ground plan, namely NW-SE and NE-SW respectively (Figure 6).

The collapses occurred in the above structures, which had the oblong direction parallel to the NE-SW direction, which is the direction towards the epicenter. Evidently, the oblong pillars (NW-SE) were of a direction

Figure 6. Map of Ceyhan town centre (A) and the exact place of the collapsed multi-story structures having NE-SW orientation (B). As shown at the schematic representation of the failures at the pillars (C) the collapse happened due to the perpendicular direction of the seismic waves.

perpendicular to the direction of propagation of the seismic waves and consequently of a lower resistance to loading. On the contrary, no collapses occurred in those of the specific structures, which had the oblong direction of the pillars (NE-SW) parallel to the direction of propagation of the seismic motion. The deformation suffered by the

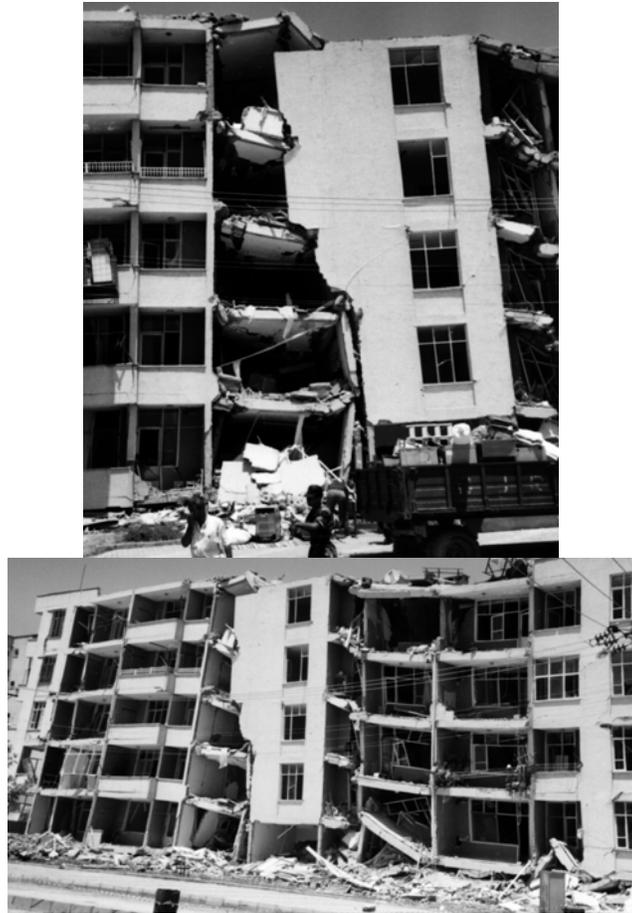
structure shown in Figure 7 from west to east is very characteristic, with collapse, compression, deformation etc of structural elements.

Figure 7. Aspects of a modern multi-story construction of NE-SW orientation, which collapsed totally.
