## **THE ADANA EARTHQUAKE (TURKEY) - SEISMOTECTONIC FRAMEWORK - GEODYNAMIC PHENOMENA - IMPACT ON THE STRUCTURED ENVIRONMENT**

**Eythymios L LEKKAS<sup>1</sup> And Emmanuel M VASSILAKIS<sup>2</sup>**

### **SUMMARY**

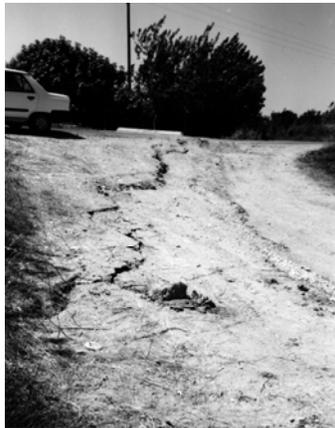
Seismic ruptures with sinistral displacement of NE-SW direction were identified after fieldwork observations. It should be noted that the general distribution of the epicentres of the recorded aftershocks displays the same arrangement with the seismic ruptures. The seismic ruptures, which extended for a length of approximately 300m between Incirlik and Yakapınar, in many locations, exhibited an en-echelon arrangement with practically no vertical displacement. This fact corroborates the sinistral displacement (Figure 3). Additionally, numerous ground ruptures were observed in the area, which are not related with the rupture caused by the fault plane but resulted from the behaviour of the ground formations during the earthquake.

**Figure 3: Part of a seismic rupture caused by sinistral strike slip movement.**

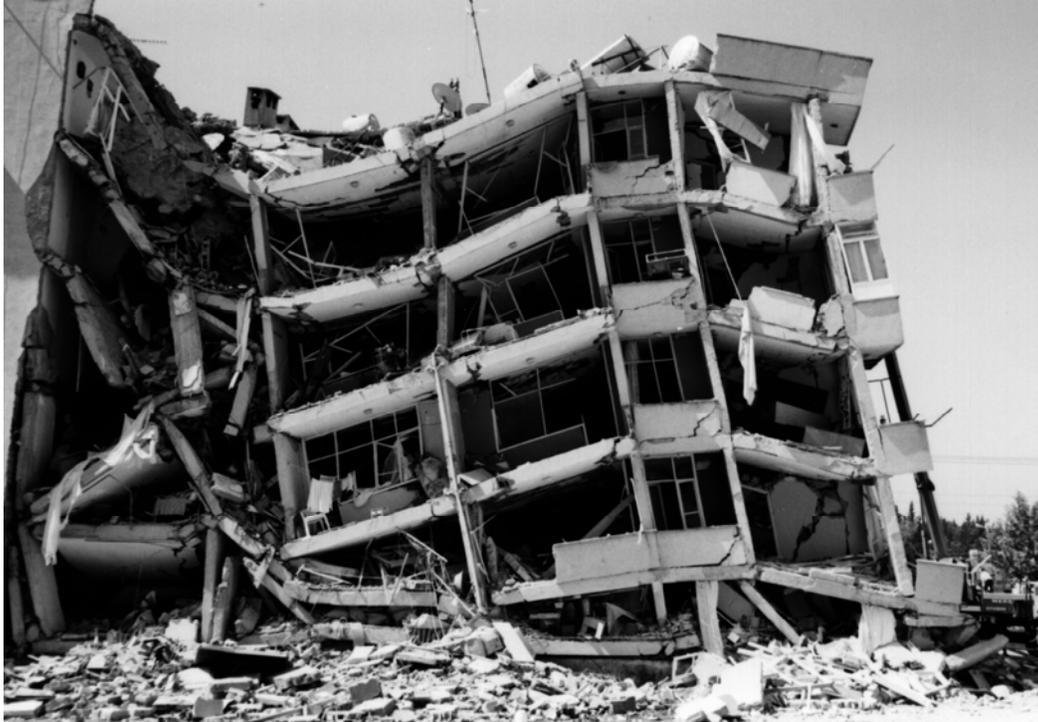
The most substantial damages occurred in buildings of the first four categories mainly in villages where at least 30%-80% of the structures suffered significant damage. Furthermore, significant damages occurred in multi-story buildings of reinforced concrete and without earthquake-design standards or with the quality of the materials significantly degraded. Such damages that led to total collapse occurred in the area of Adana and in the area of Ceyhan (Figure 4).

**Figure 4: Total collapse of multi-story building at the city of Ceyhan.**

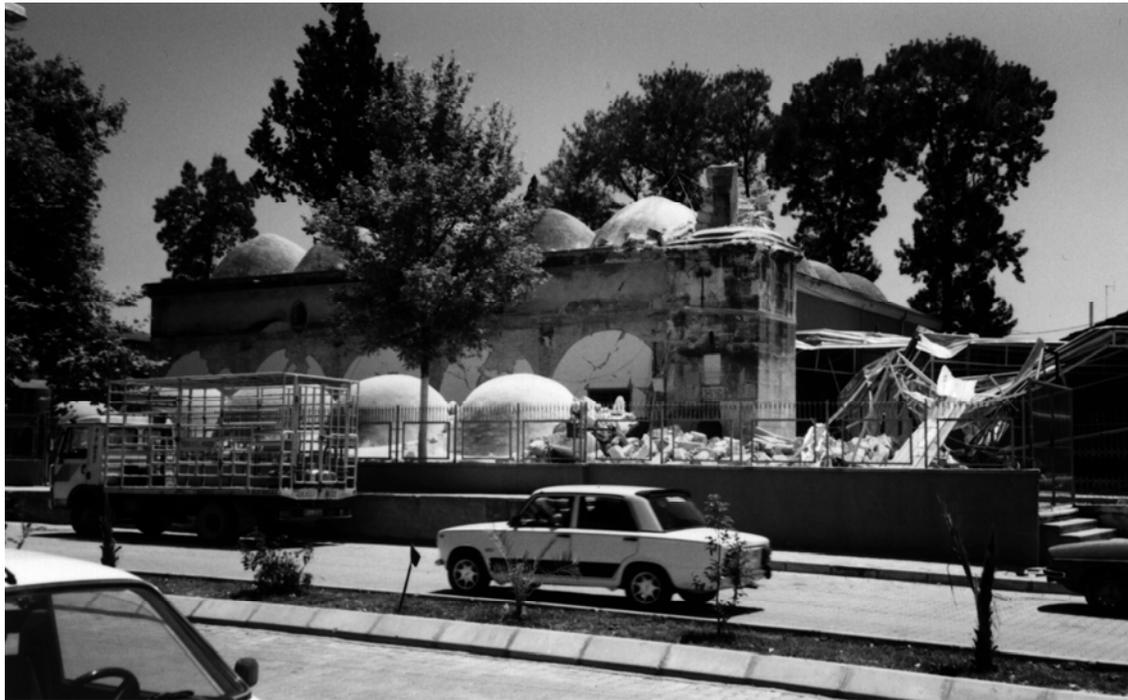
Significant damages were also observed in the historic monuments of the area and mostly in mosques and minarets (Figure 5). These damages showed a selective development in the upper parts of the minarets [Lekkas and Vassilakis, 1999]. Additionally in the vicinity of the villages Yakapinar-Abdioglu, some industrial buildings with metal framework suffered significant damages.

**Figure 5: Partially collapsed mosque in the city of Ceyhan.**

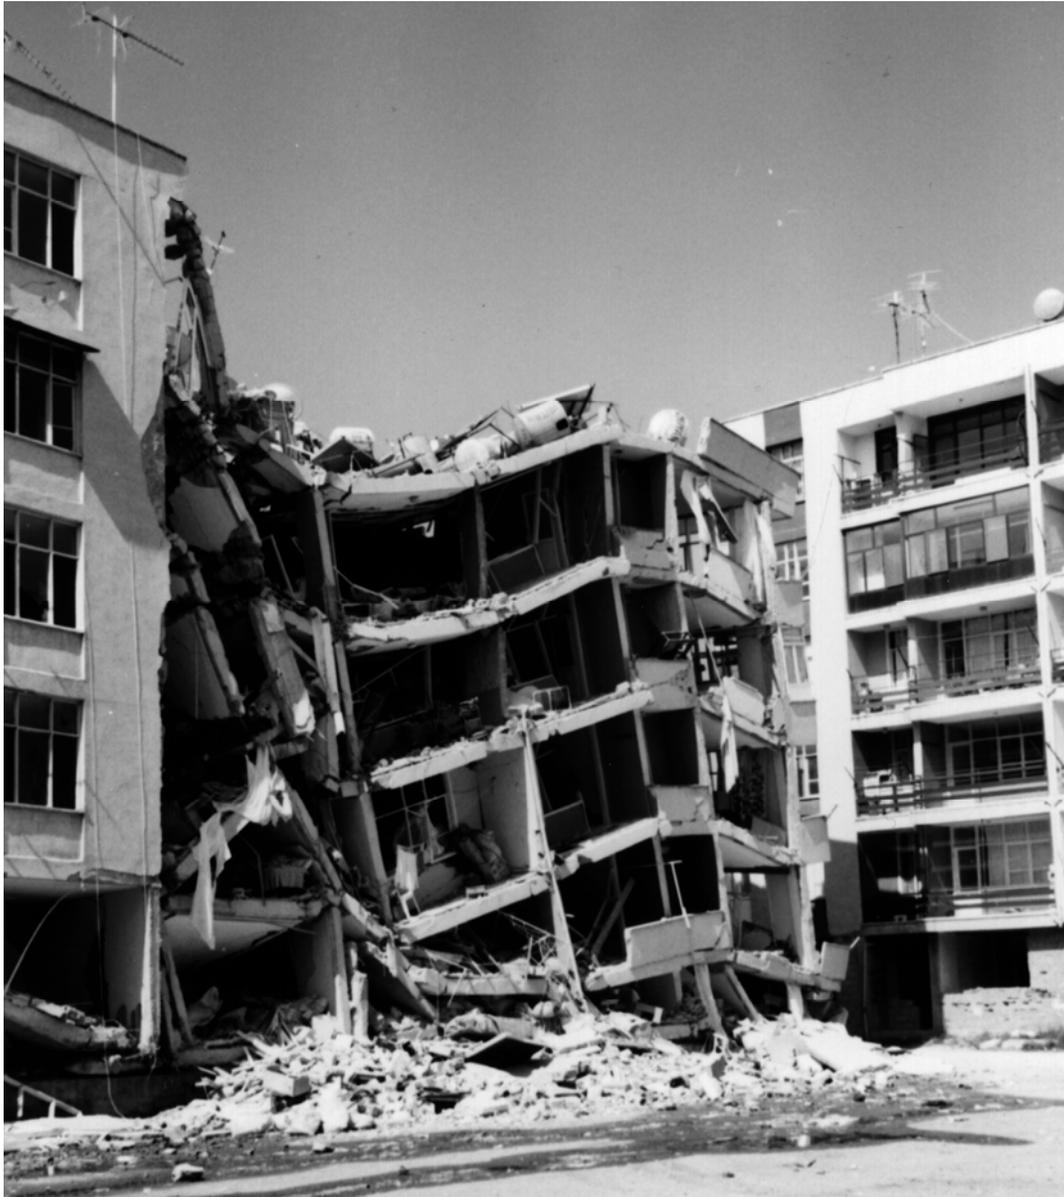
It is interesting that there is a correlation between the type of building and the type of damage suffered. The extent of the damage however, is also related to the construction quality, the quality of the materials, the age of the structure, the maintenance but also to the geographic location and the azimuth position with respect to the epicentre. Some of the reasons that caused the damages are similar to those determined in other earthquake cases in Turkey like the earthquake of Dinar [Carydis et al., 1995]. Such reasons are: (i) soft first story, (ii) inadequate detailing and reinforcements of column-beam connections and columns, (iii) design of strong beam/weak columns rather than strong column/weak beams and (iv) succession of flexible and rigid parts in big buildings (Figure 6).

**Figure 6: Partially collapsed building, due to the succession of flexible and rigid structural elements.**
