**Sexto Congreso Nacional y Conferencia  
Internacional de  
Geología Ambiental y  
Ordenación del Territorio**

## INVESTIGATION ON THE UNEQUAL DISTRIBUTION OF DAMAGE DURING THE HANSHIN EARTHQUAKE (KOBE, JAPAN).

Lekkas, E., Kranis, H., Leounakis, M. & Stylianos, P.

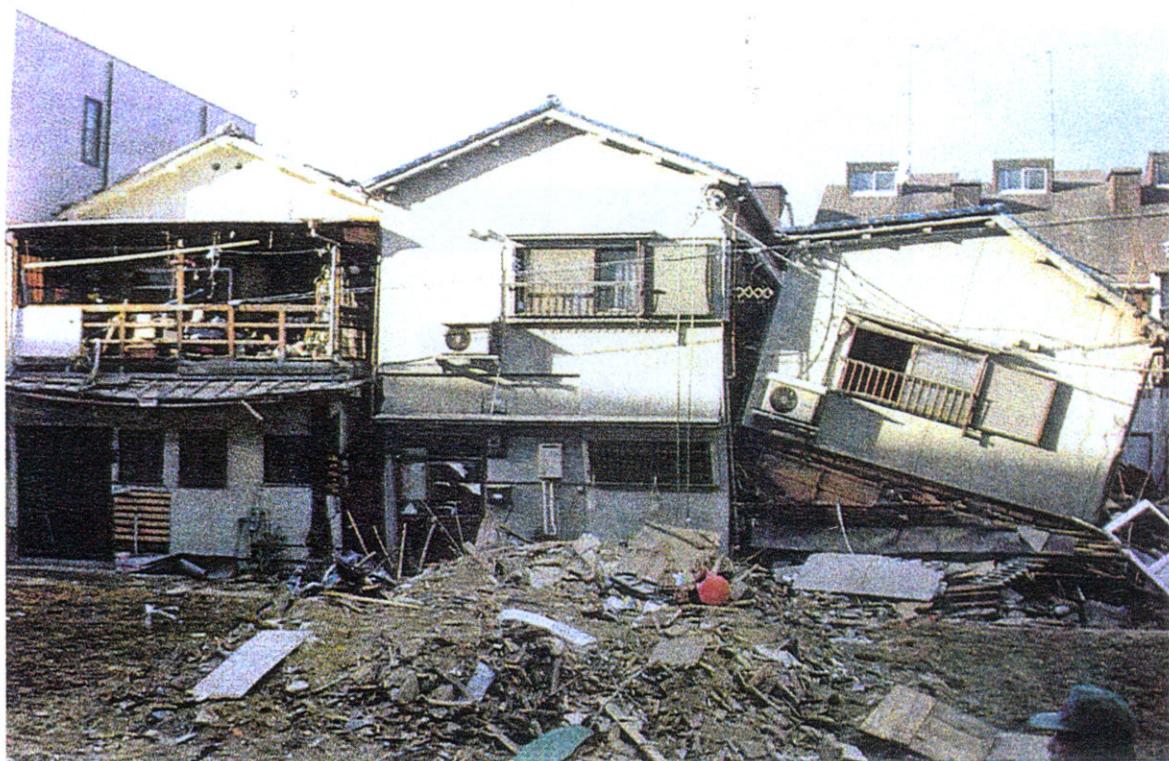
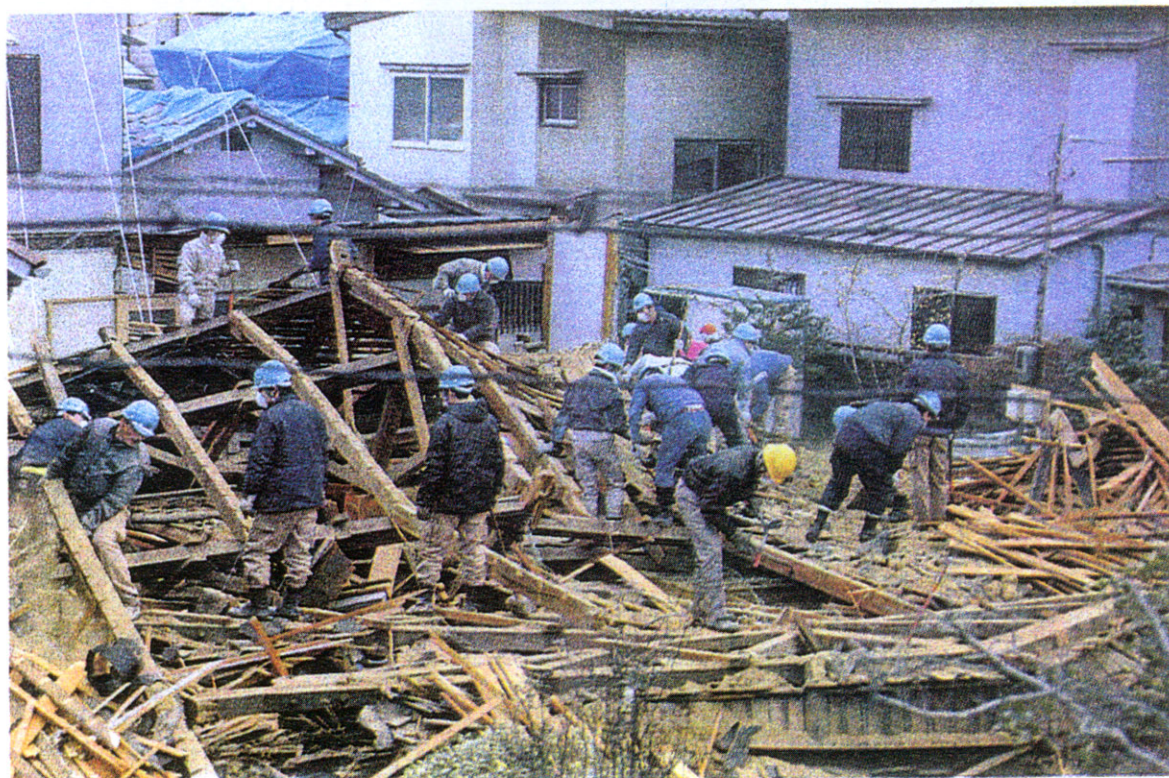
The recording showed that the vast majority, over 80% of the buildings were wooden ones so that they could constitute a valid marker of the distribution of damage in the surveyed location (Fig. 2). Besides the utilization of the wooden buildings as an index had other advantages over the other constructions, such as approximately similar height and uniform method of foundation; besides they were more or less of the same age and the estimation on the damage was easier and were accurate.

Important damage and collapse in wooden structures cause by the earthquake of January 17, 1995.

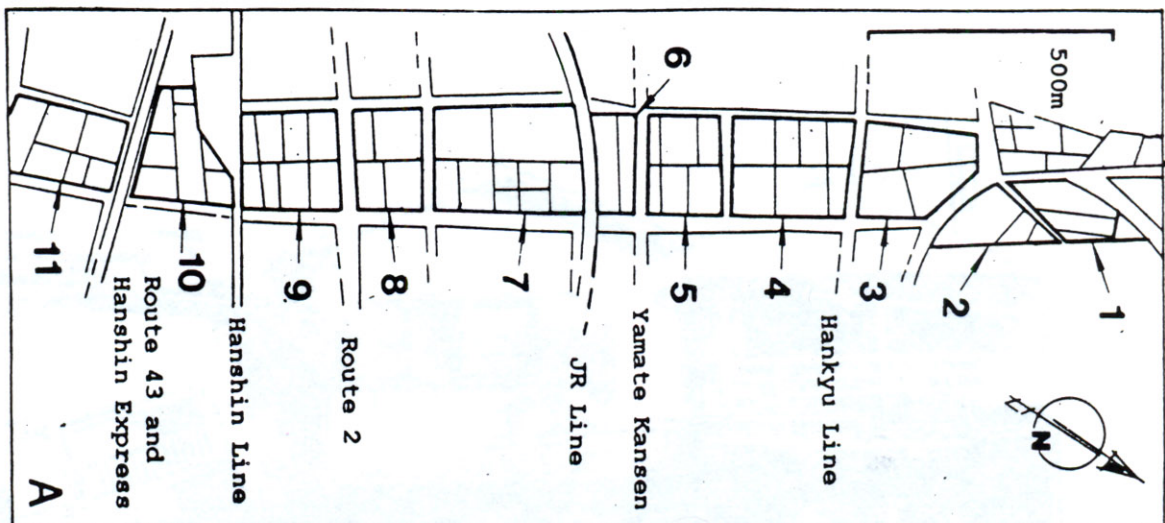
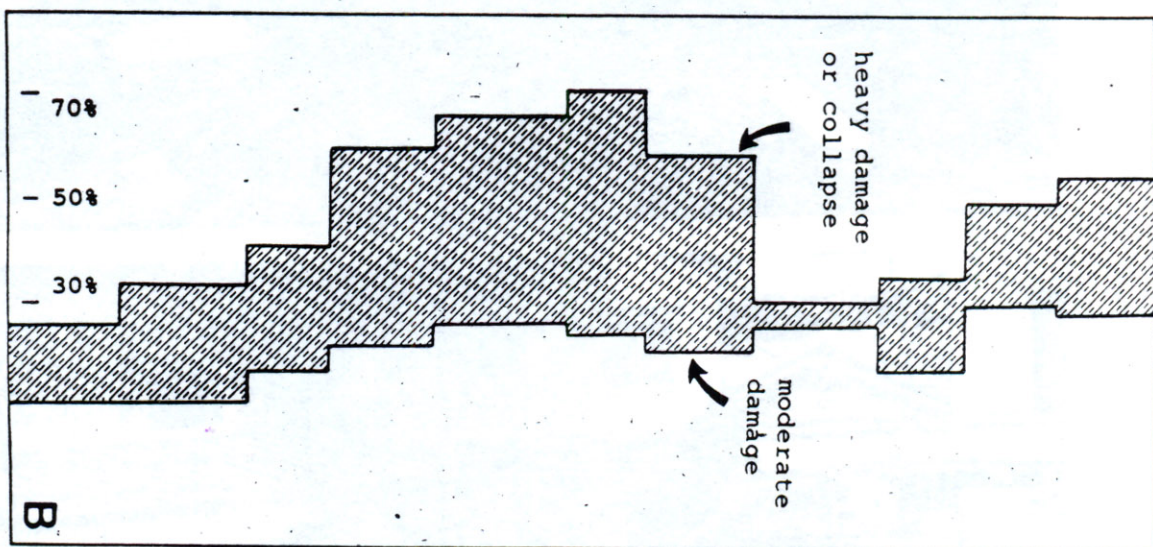
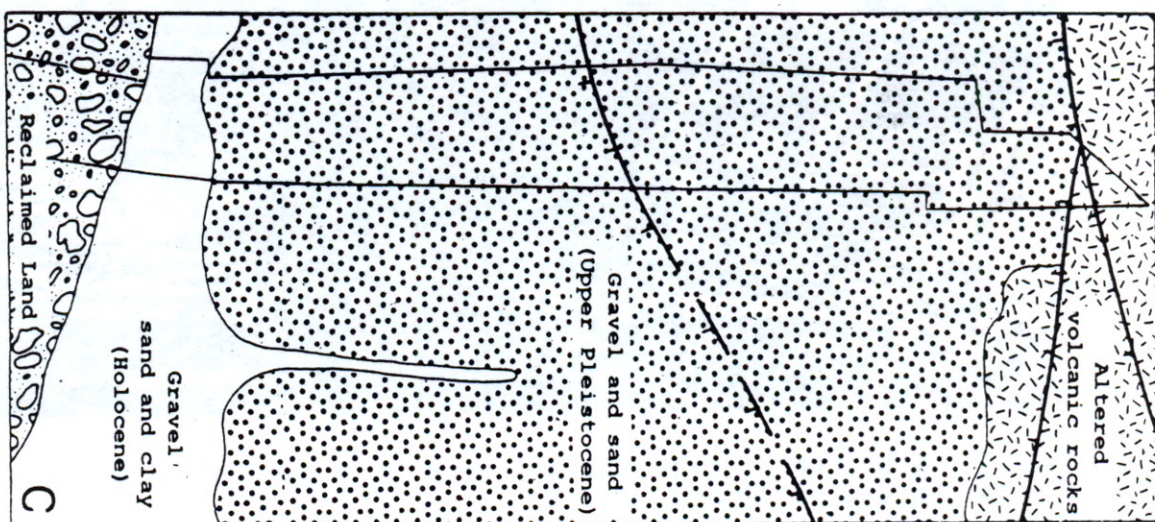
Fig. 3 The sectors that the study area was divided (A), the damage percentage (B) and the geological map of the area (C). The correlation denotes the crucial impact of the faults on the distribution of damage.

The same holds for the buildings that suffered moderate damage despite the slight differentiation in certain parts of the area that appears (Fig. 3); in this case too, a valid correlation could be insecure. However, there is an increase in the damage at the vicinities where faults pass, while there is also a general downward trend of the damage to the south.

On the contrary, where the damage was "heavy" or "collapse" there is a clear unequal distribution with distinct minima and maxima. Thus, in sectors 1, 2 and 6, 7 the damaged percentage is significantly high and can be attributed to the underlying faults there.

On top of that, in the adjacent sectors (5, 8, 9) there is a gradual decrease which can be ascribed to the larger distance from these faults.

It has to be remarked that there is no lithological differentiation in the Upper Pleistocene formations, which could be held responsible for the abovementioned differentiation of the damage percentage.

Finally, we must draw the attention to the fact that again heading southwards, there is a gradual decrease in the damage percentage (concerning this very class of damage).
