## GEOTECHNICAL - NEOTECTONIC FOUNDATION CONDITIONS OF THE MENDENITSA CASTLE (FTHIOTIDA, CENTRAL GREECE)

I. MARIOLAKOS<sup>1</sup> & H. KRANIS<sup>1</sup>

### ABSTRACT

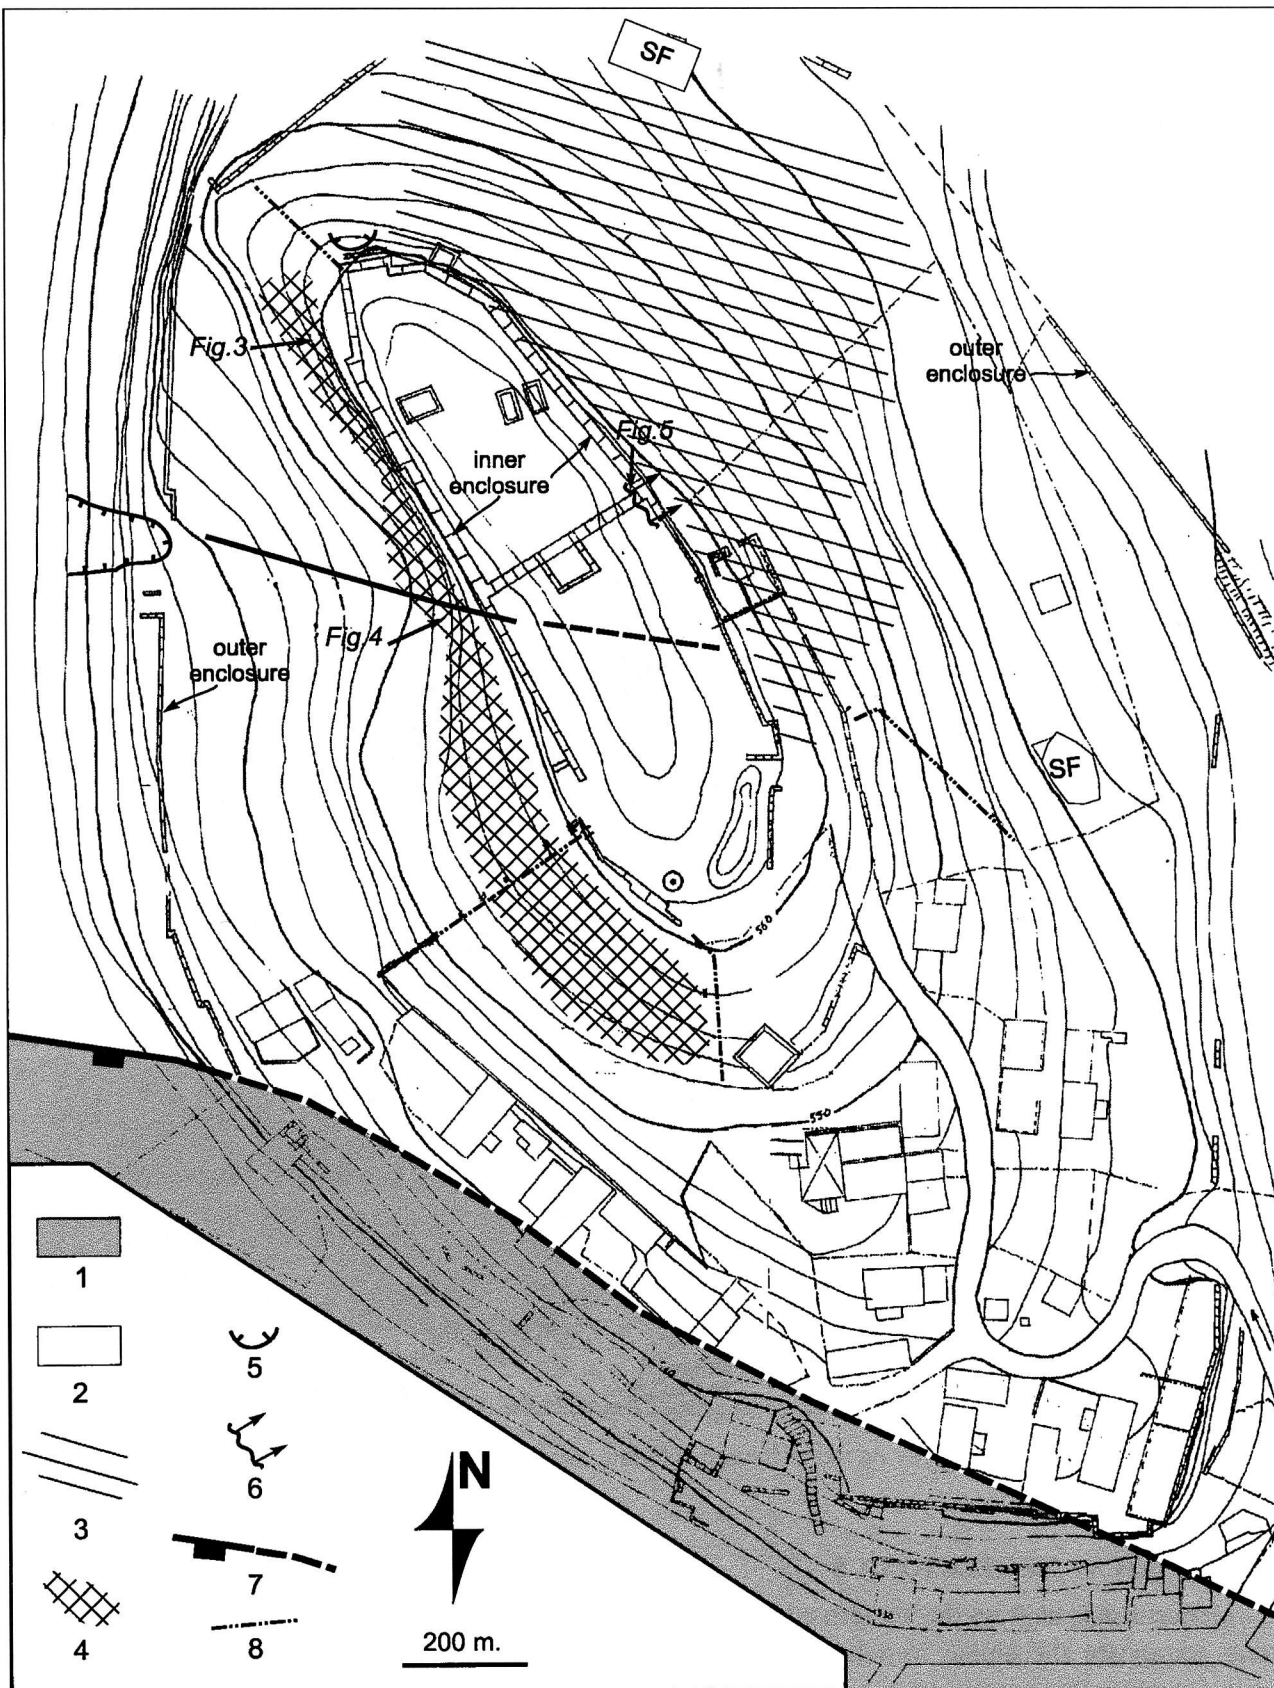
**Fig. 2:** Geologic - tectonic map of Mendenitsa horst. 1. Mendenitsa formation; 2. dolomites; 3. regolith; 4. cataclasite; 5. subsidence; 6. super-structure fracture and displacement; 7. fault; 8. wire fencing; SF: sheepfold. Contour interval: 2m.

The main tower also faces the danger of complete collapse, while local subsidence is observed at the northwestern edge of the castle (Fig. 2) and must have been caused by a collapsed tunnel dug to connect the castle with the nearby village (Karavidia).

- The restoration of land use around the castle, that is removal of the sheepfolds and of wire fencing between the two enclosures.
- Stabilisation of the slope, with any appropriate means (mainly plantation)
- Instrumental monitoring of the fault that affects the superstructure itself, so that all necessary steps can be taken to avoid further negative consequences by fault creep.
- Immediate restoration works on the foundation of the northeastern wall and sealing and reinforcement of the fracture that threatens this part with total collapse.

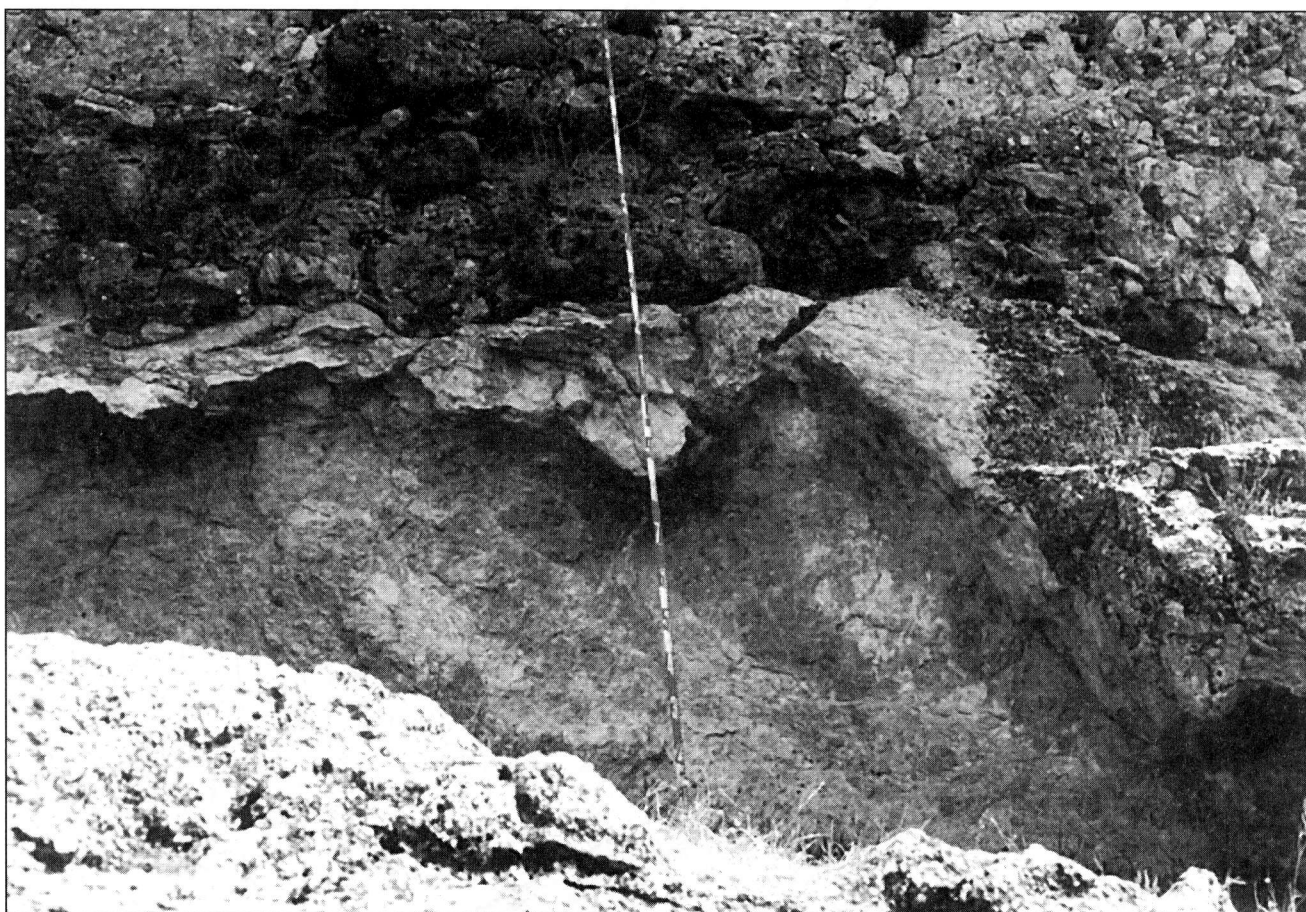
The castle has been founded on the tectonized dolomites (Fig. 3). On the northeastern slope of the acropolis occurs a 10-30 cm.-thick regolith, stabilised by the existing shrubs and other plants. This regolith is less developed on the southwestern slope, mainly because of the increased gradient there. At the same side of the hill, the terrain is craggy, with outcrops of the unweathered dolomites protruding all over the slope.

**Fig. 3:** Foundation of castle directly on the tectonised dolomite (cataclasite). 2-m. rod for scale. For location of photo see fig. 2.

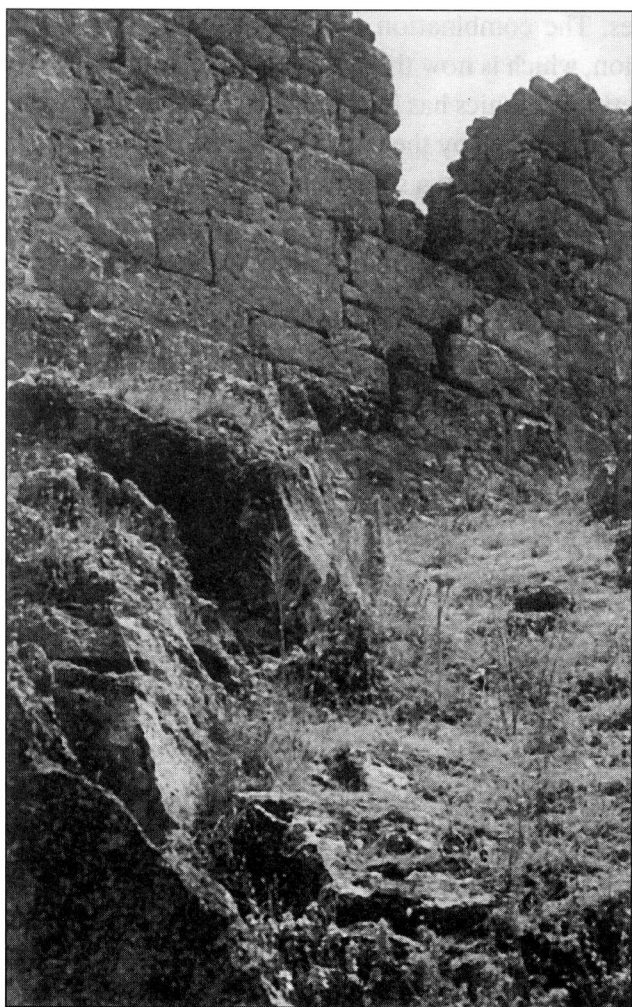
A smaller-order linear tectonic feature is located within the horst. It is a WNW-ESE fracture (Figs. 2 & 4) and appears to have affected the castle itself. It has displaced and destroyed a part of the southwestern inner wall and may be responsible for the collapse of a large portion of the southeastern inner wall.

**Fig. 4:** Fault within the Mendenitsa horst, affecting the superstructure. For location see fig. 2.

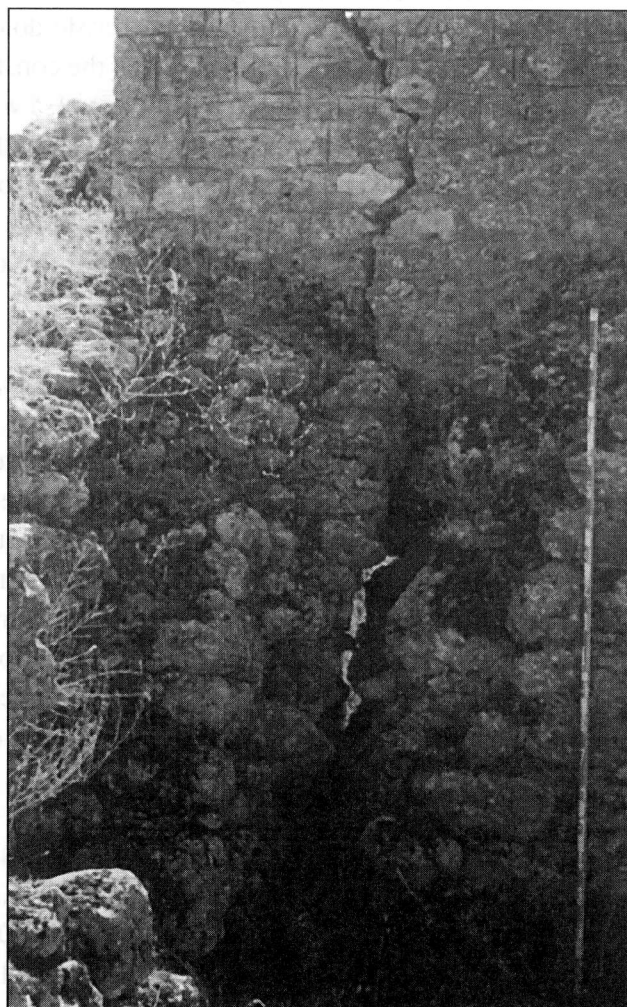
**Fig. 5:** Active fracture within the the superstructure. 2-m. rod for scale. For location see fig. 2.
