**THE BOUMERDES-ZEMMOURI, (ALGERIA) EARTHQUAKE (MAY 21,
2003, Mw=6.8):
RESULTS OF FIELD RECONNAISSANCE ON DAMAGE EVALUATION,
SURFICIAL DEFORMATION AND GEOLOGICAL SITE EFFECTS**

Efthimios L. LEKKAS¹ and Haralambos D. KRANIS²

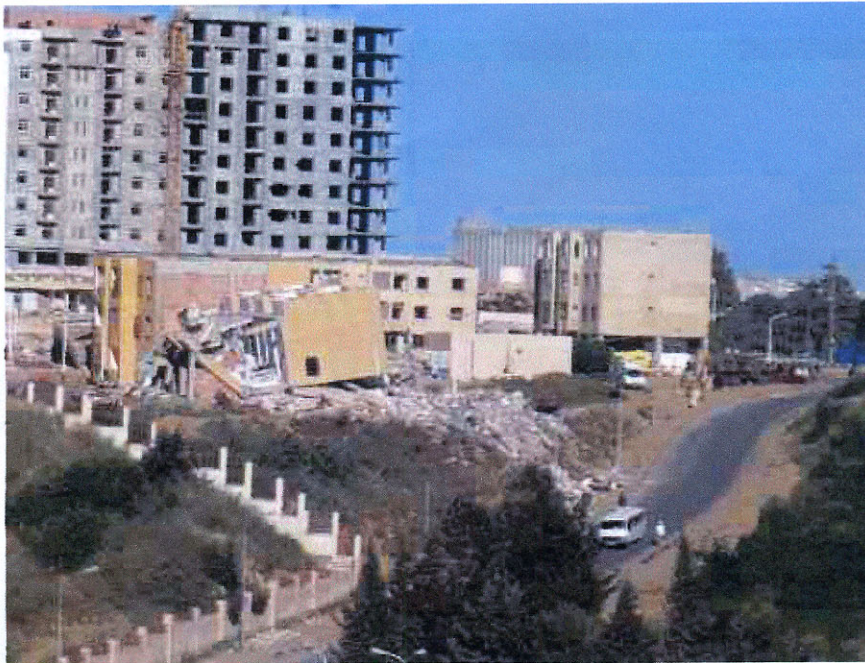
The geotechnical conditions in Boumerdes are more or less uniform, which means that they did not play any important part in the spatial distribution of damage. The foundation soil consisted of dry, compact sandy material, a fact that prevented the occurrence of liquefaction in Boumerdes. However, it is noteworthy that the morphological conditions seemed to control the distribution and severity of damage, at least to some extent. Specifically, the collapses of buildings located along, or close to natural or artificial escarpments (such as river banks) were indicative of localized increase in peak ground acceleration. This resulted in toppled buildings (Fig. 2) and massive collapses. Such case was also observed in the Athens, Greece earthquake of September 7, 1999 (Mw=6.0), where localized, linear development of damage was observed along the banks of Kifissos river and its tributaries (Lekkas [9]).

Figure 2. Toppled building, located on the crest of a natural escarpment in Boumerdes.

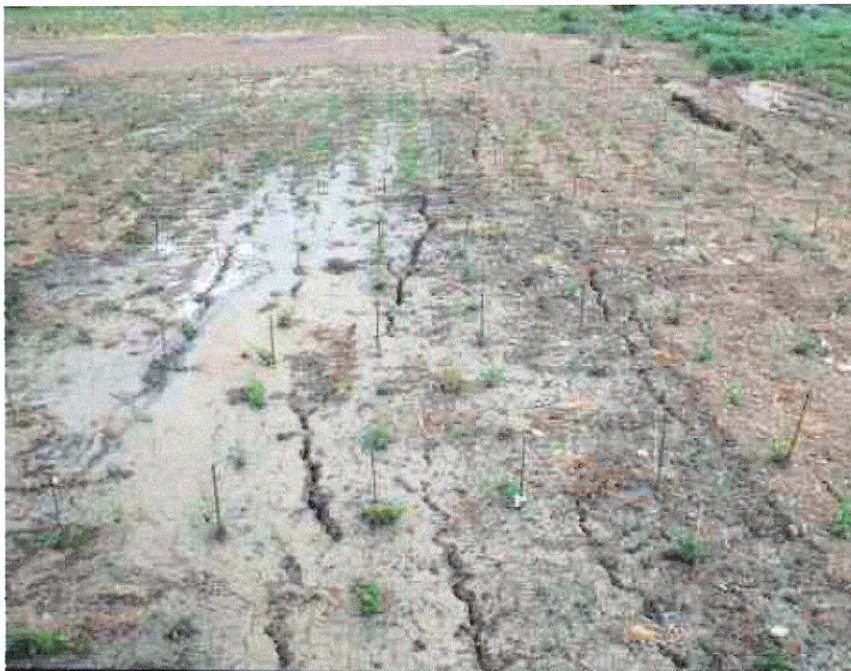
Contrary to the situation in Boumerdes, in Zemmouri, Djinet and Dellys, liquefaction phenomena were quite widespread. The effect was quite serious close to the Zemmouri and Djinet, but occurred mainly in rural, uninhabited areas. Sand was liquefied and ejected through linear ground fissures of considerable length (between a few m. and some tens of m.), trending approximately N20-40E (Fig. 3). There were also manifestations of lateral spreading on the banks of Isser River (Fig. 4). Rockfalls and other slope failure occurrences were limited in number and magnitude. Most of them took place on the coastal national road and a few along the Mediterranean coast. The former affected well consolidated but densely fractured sandstones exposed on steep road cuts; the latter were noticed on loose sand dunes. Coastline retreat and uplift of the sea floor was also observed: the magnitude of uplift ranged between 0.4-0.8 m, between Boumerdes and Zemmouri (Yelles et al. [10]).

Figure 3. Ground fissures and liquefaction close to Djinet. The trend of the fractures is approximately N35 E.

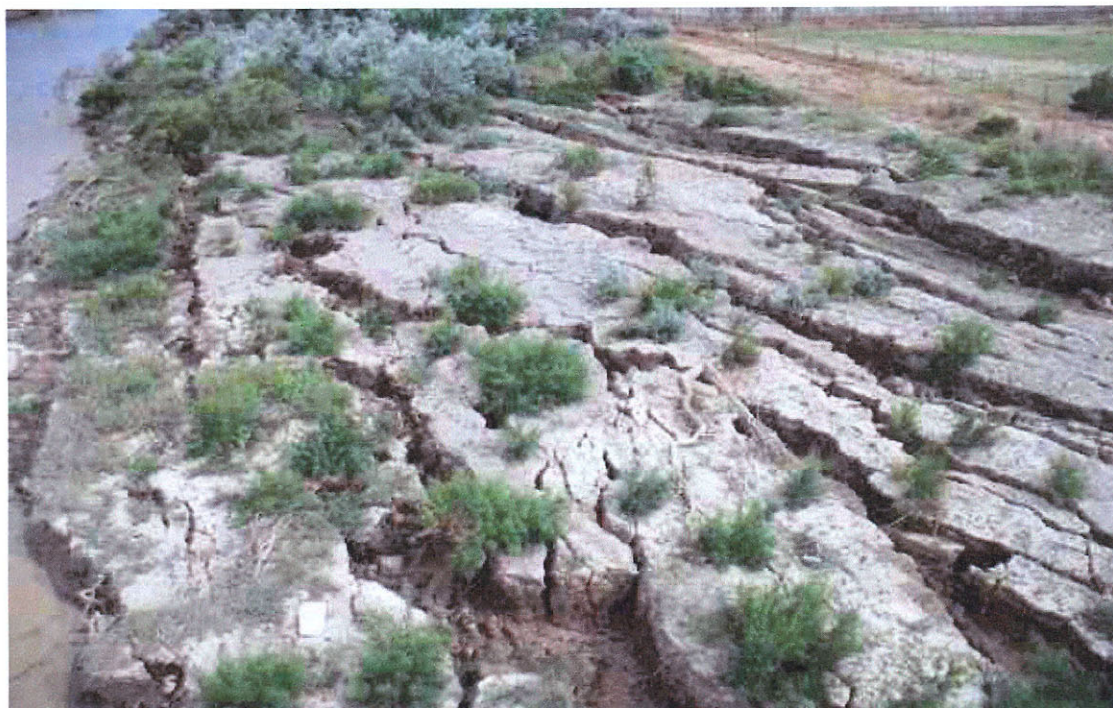
Figure 4. Lateral spreading on the banks of Isser River.

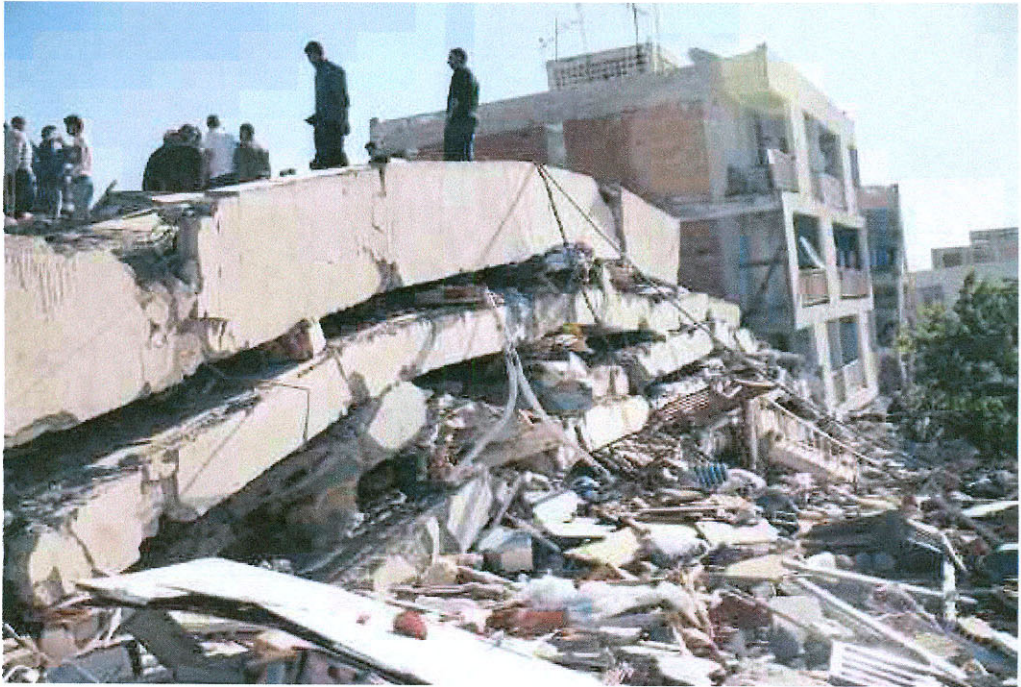
In Boumerdes, the affected buildings were four- to six-story residential blocks that housed working-class families. These constructions consisted of reinforced concrete frame with brick infill walls. Most collapses or heavy damage were due to the fact that the constructions behaved as soft first- (and/or second-) story. This is attributable to the following factors: (i) the first stories (ground floors) were had commonly very large openings, as they were used for commercial purposes and the gravity load-carrying elements of the second floor were insufficient; (ii) the exterior cavity walls consisted of an outer leaf that enveloped the R/C frame and the inner shell had usually very low cohesion with the frame. This meant that the stretcher-bond cavity walls did not play any active part in the shear strength of the buildings and the constructions were subjected to column-shearing at the tops of the first stories. The collapses were mostly sandwich-type and in a few cases pancake. (Figs. 5, 6). Also, in a few cases, as described in the previous part, localized sharp increase in PGA led to the toppling of buildings.

Figure 5. Pancake-collapse of four-story residential building in Boumerdes.

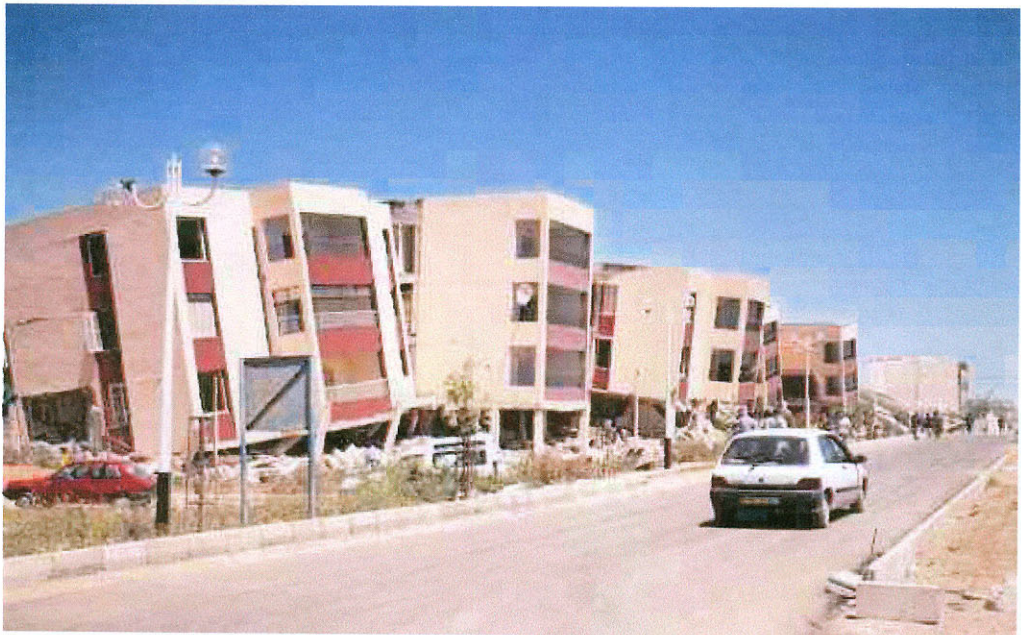
Figure 6. Soft ground floor (first story) at several residential blocks in Corso, at the eastern outskirts of Boumerdes.

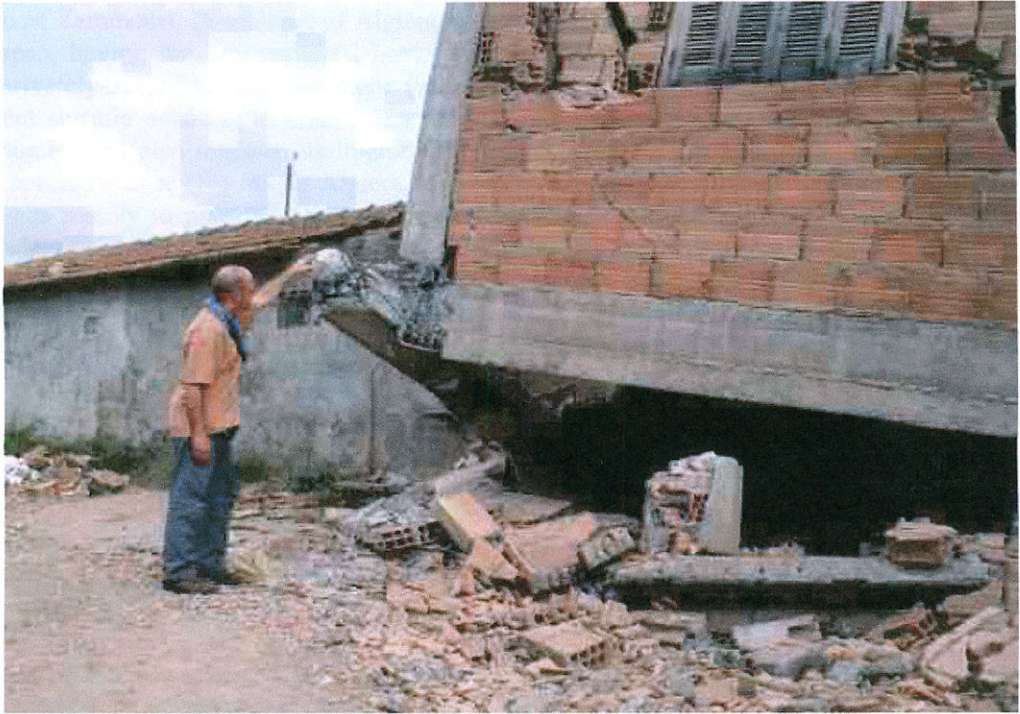
Figure 7.Column-beam failure due to insufficient seismic detailing at a private home in Zemmouri.

The town of Zemmouri, 70 km east of Algiers, was practically reduced to debris; very few buildings did not collapse, having however suffered heavy structural damage. In this town, again the construction quality privately-owned houses was poor (including low-quality materials and wrong construction – insufficient seismic detailing in columns, strong beam/weak column, etc) (Fig. 7). However, not only private homes, but also modern, multi-story apartment blocks (most of them still under construction) suffered severe damage (Fig. 8). In Algiers, mainly the western part of the city was hit. In this case, the damage was mainly to private homes that were constructed without adhering to the Algerian seismic design code.

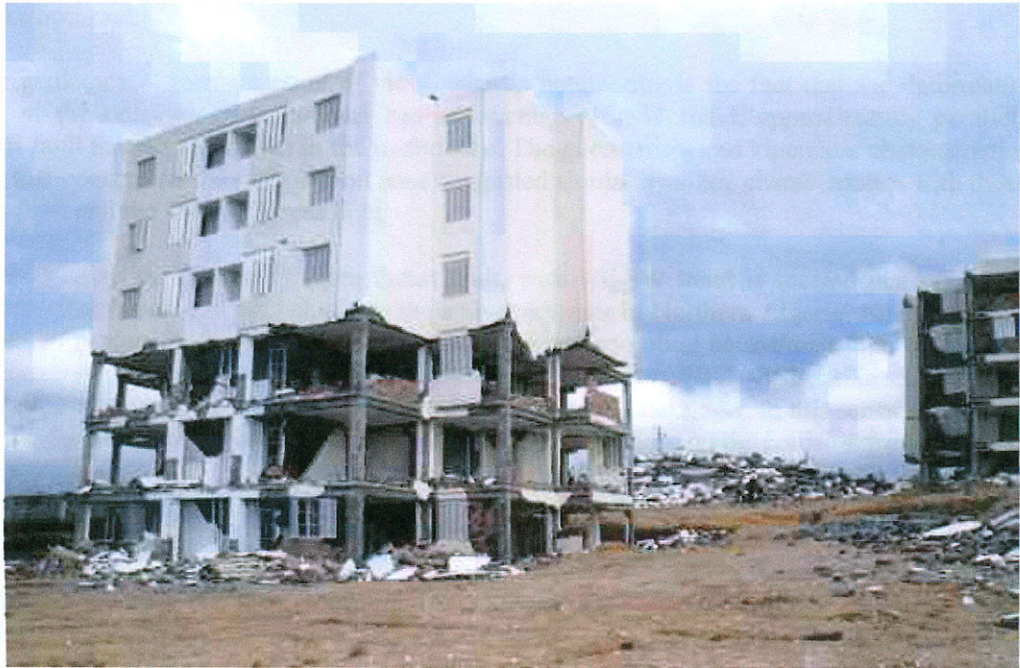
Figure 8. Loss of exterior shell (foreground) and total collapse (background) in newly-built apartment blocks in Zemmouri.
