Kourliافتis G.¹, Vandarakis D.², Kapsimalis V.², Vassilakis E.¹, Poulos S.¹, Petropoulos A.¹

Introduction

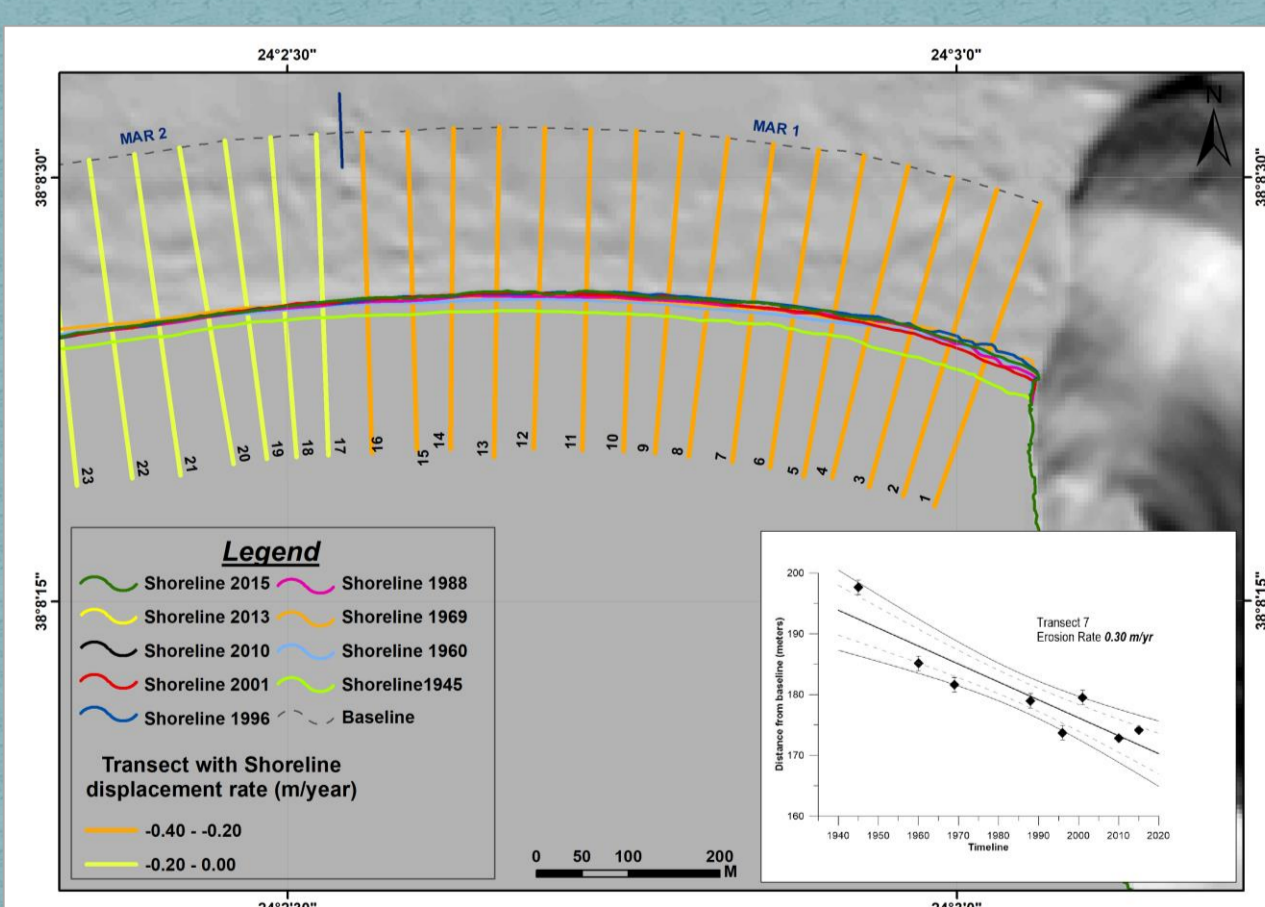
Figure 9. Shoreline displacement rates at Area 1 (East lagoon's draining channel)

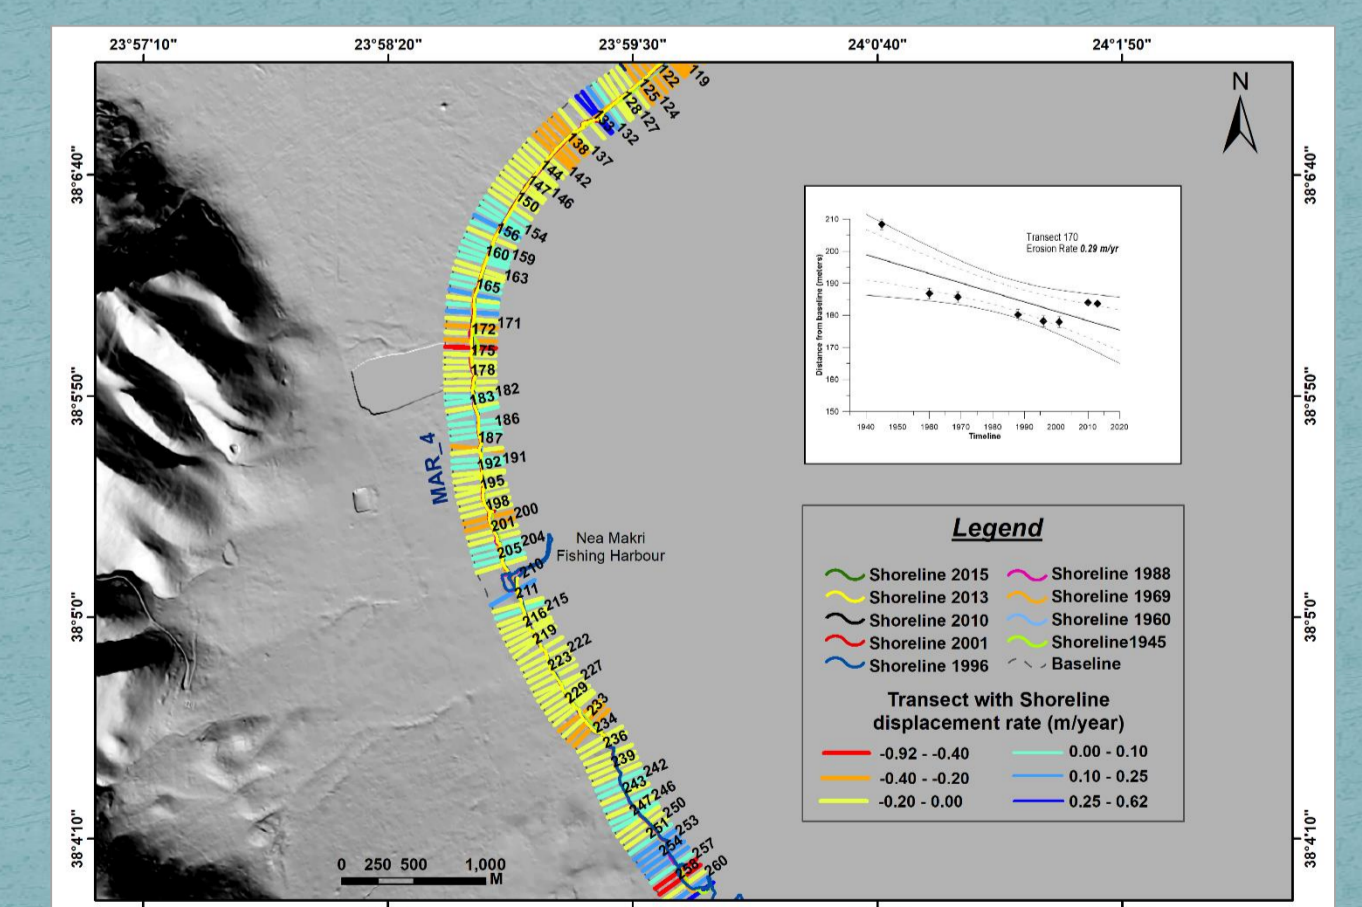
Figure 12. Shoreline displacement rates at Area 4 (Nea Makri)

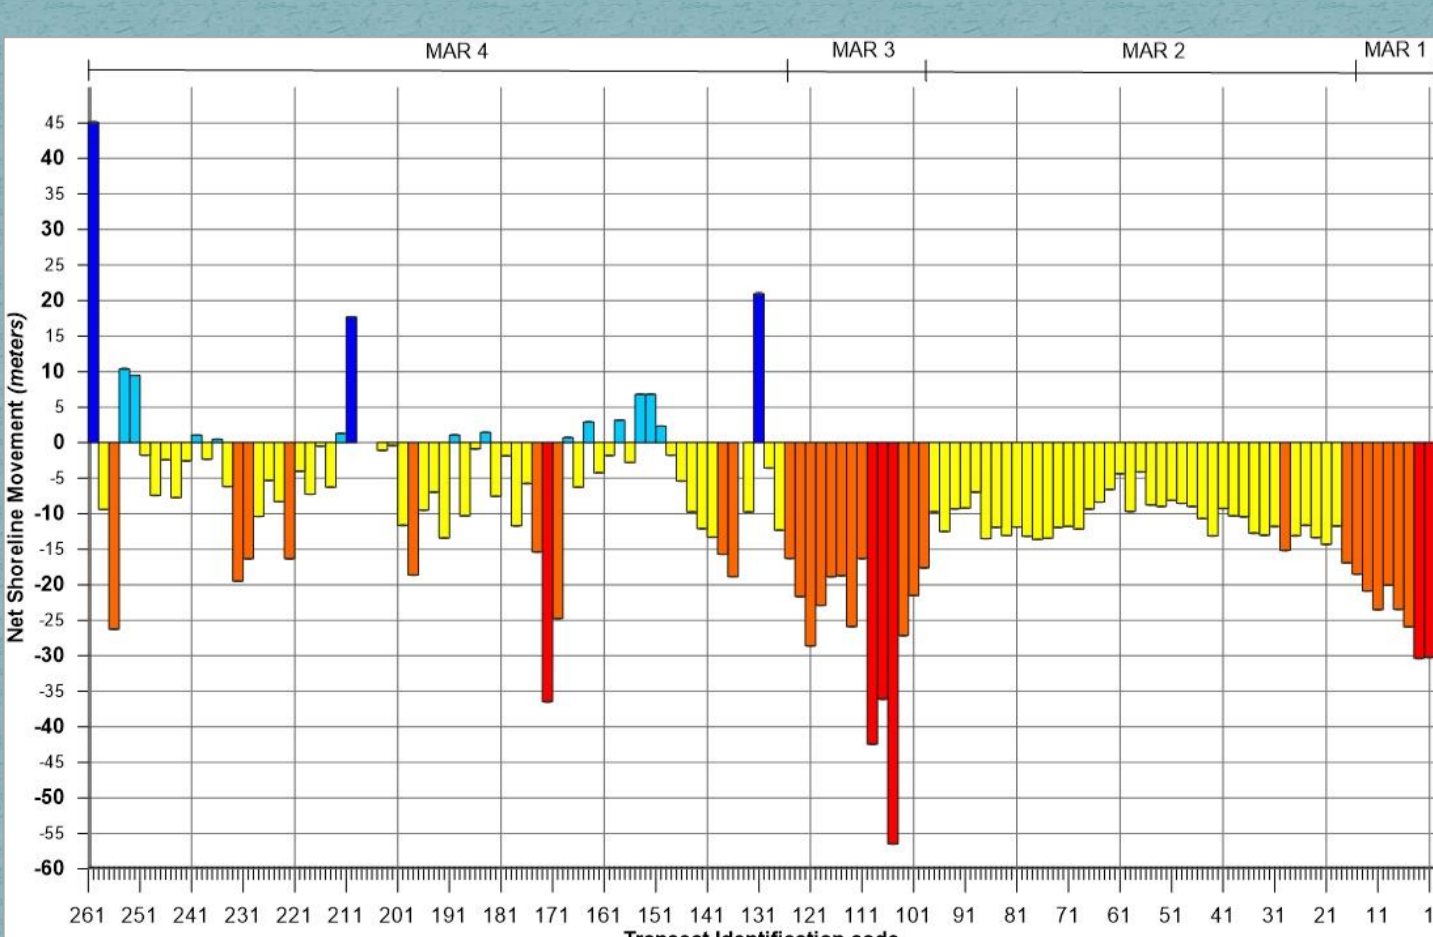
Figure 13. Distance between oldest and youngest shores (NSM, Thieler et al. 2009)

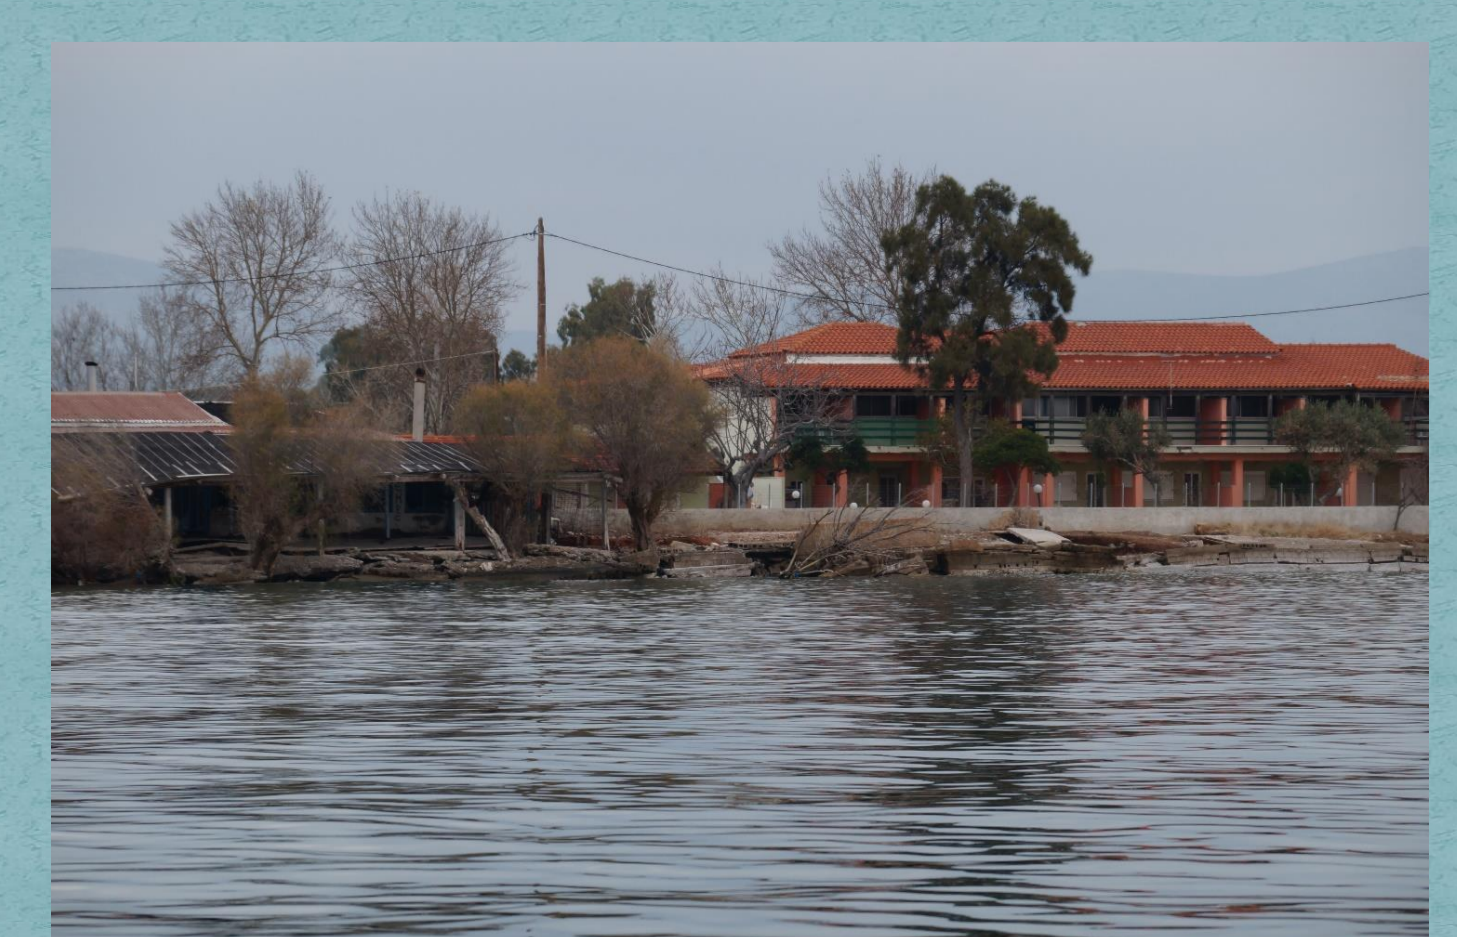
Figure 14. Destroyed restaurant by coastal erosion at Area 3 (estuary of Kenourgio stream)

The exposition of the coast to the southern waves, the reduced sediment supply from local rivers, due to the Marathon's Dam and secondly of the morphology of their riverbeds, they have been filled because of the sea level rise the last 50yrs (IPCC, 2007). The lack of sediment supply, the sediment's composition and the morphological appearance of the submarine basin at the northeast of the Bay are mainly responsible for the coastal retreat along with the sea level rise.
