# JISDM 2019

4<sup>th</sup> Joint International Symposium on  
Deformation Monitoring

## Multitemporal Surface Deformation Analysis of Amyntaio Slide (Greece) using Remotely Piloted Airborne System and Structure-from-Motion photogrammetry

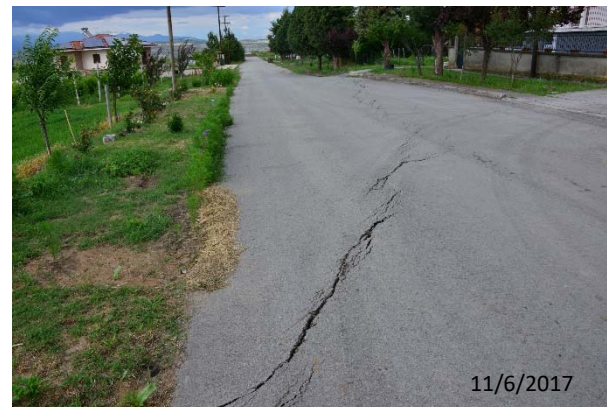
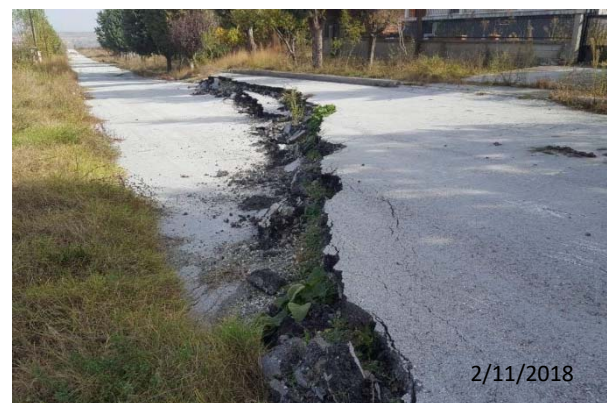
Figure 3. The main E-W trending surface fracture immediately after the landslide (top) and fifteen months later (bottom). It is clear that the fracture is still active and the displacement exceeds 0.7 meters.

Several surface fractures have appeared around the wider area of the village either on the road network or in the cultivated parcels (Figure 3).
