Introducing an innovative methodology for mapping rock-discontinuities, based on the interpretation of 3D photogrammetry products. The case of Akronafplia castle

Vassilakis Emm.^{1*}, Stavropoulou A.¹, Konsolaki A.¹, Giannopoulos I.-K.¹, Petrakis S.^{1,2}, Kotsi E.¹, Lekkas E.¹, Kokkoromytis A.¹

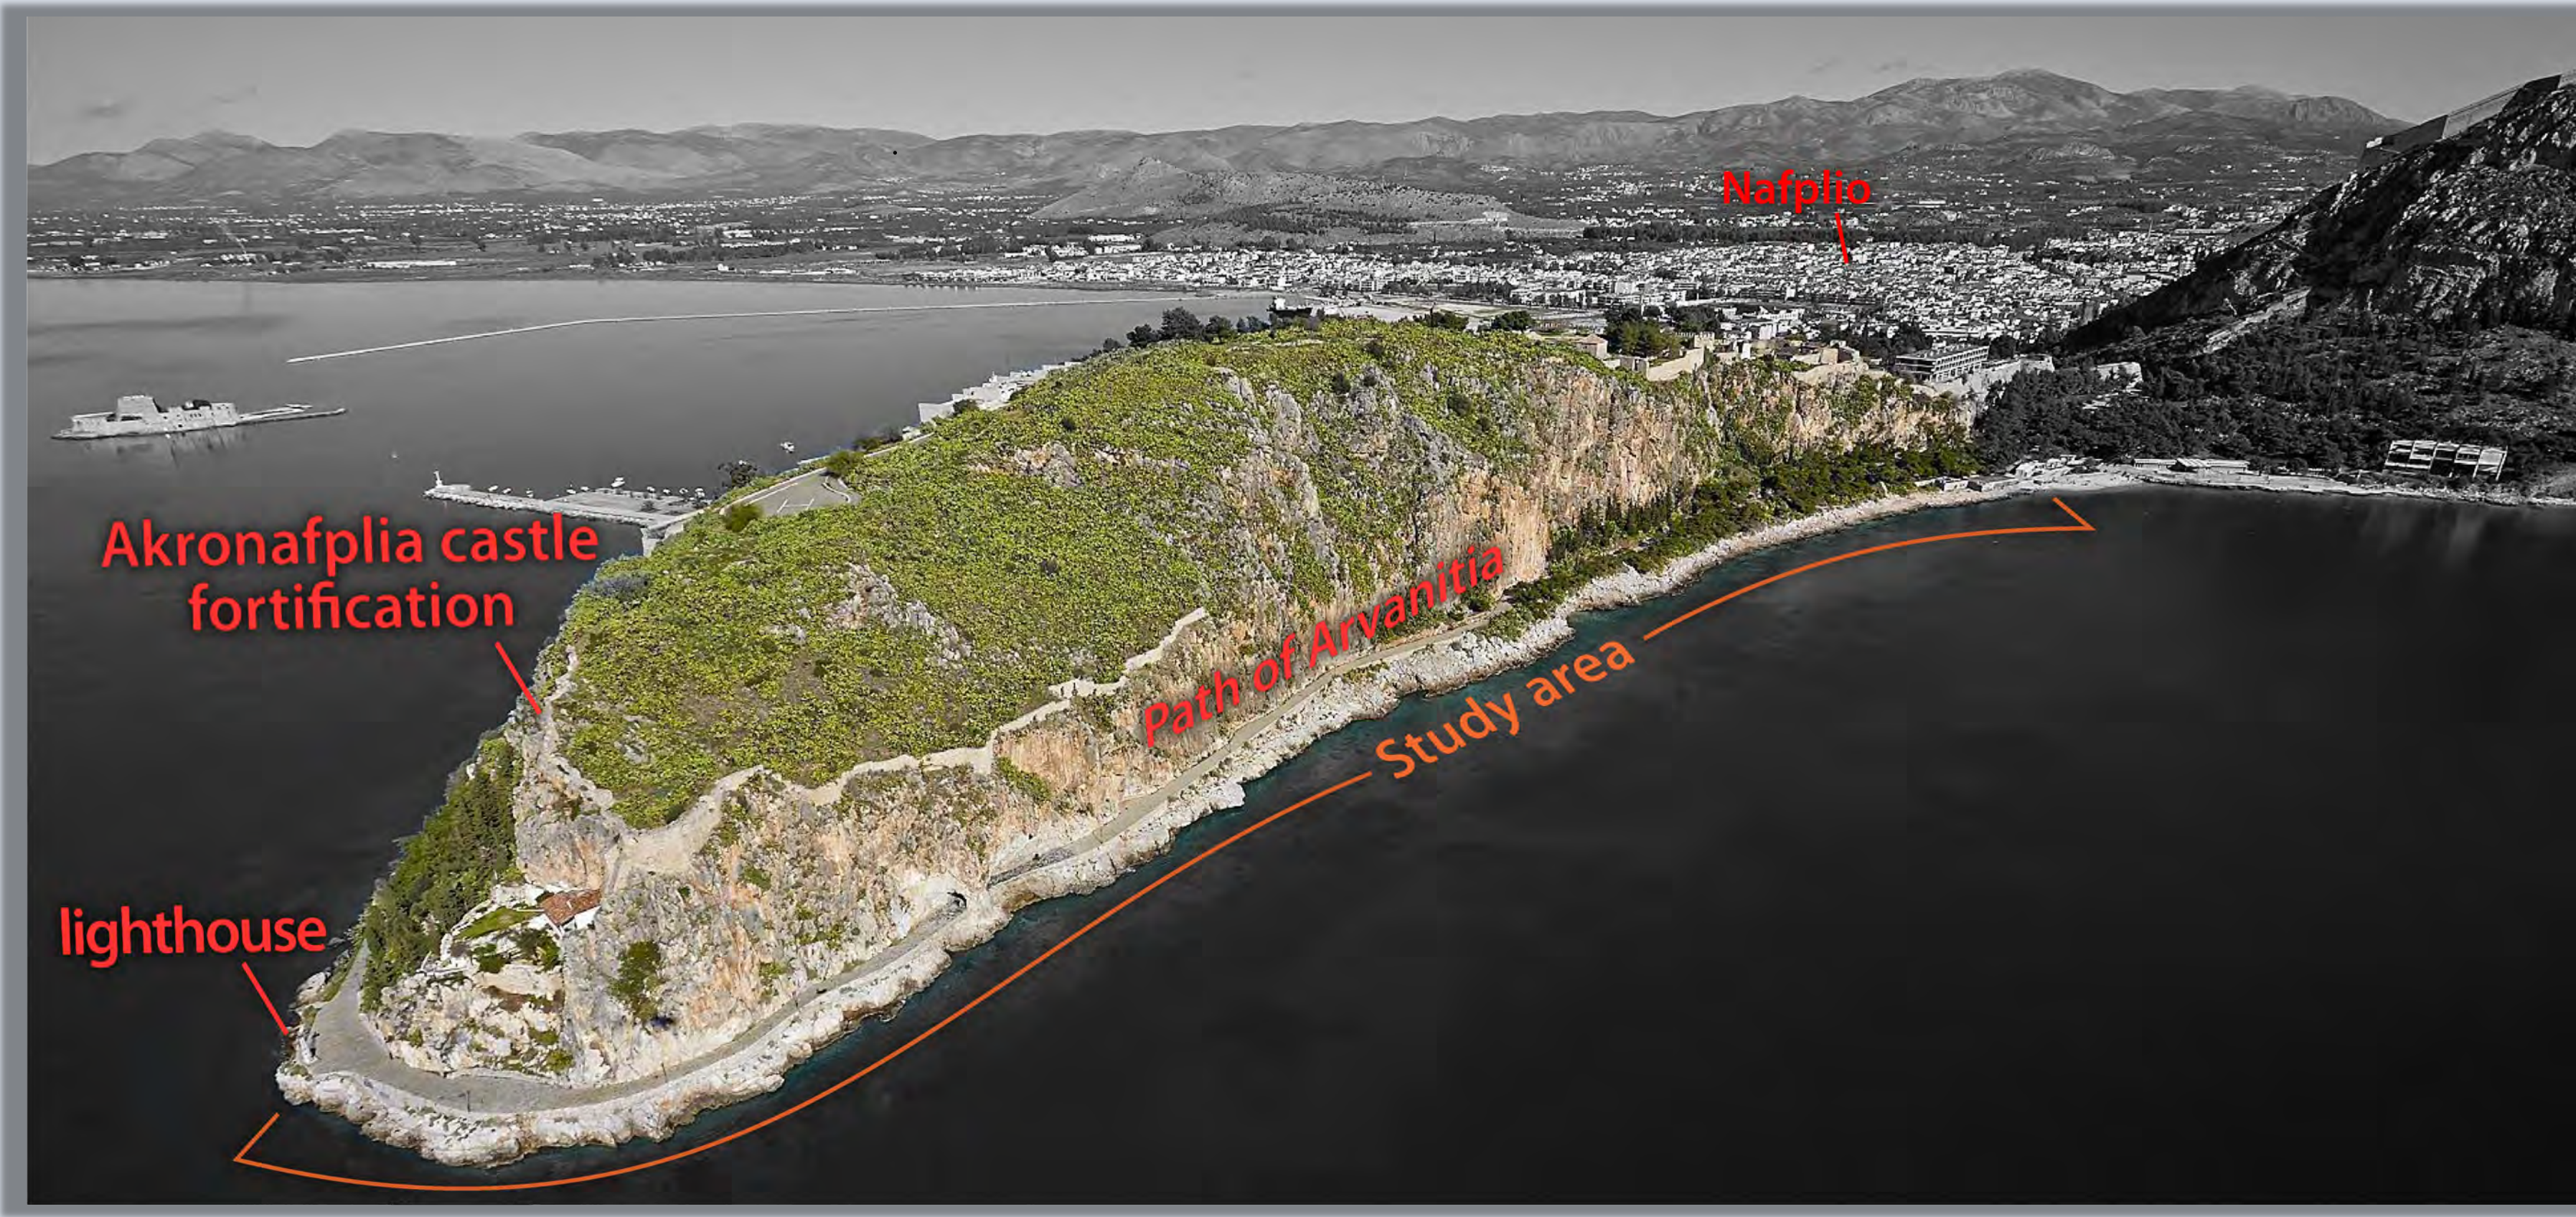
The described methodology is applied at the steep slopes of the "Path of Arvanitia" [image above], at the outer walls of Akronafplia castle, in the S border of the old city of Nafplio, aiming to map and analyze the rock discontinuities of the alpine basement of the castle. A promenade was constructed along the rocky coastline that surrounds the peninsula, used by the city inhabitants during the last few centuries. It is a rather **risky trail** characterized by strong relief with steep, almost vertical, rocky slopes, mainly at its S and W parts[i-iii].
