The Kobe Earthquake: Geodynamical Aspects

The seismotectonic setting of the Kobe area (Japan) - the concomitant geodynamic phenomena of the Hanshin Earthquake (17 January 1995)

E. Lekkas, H. Kranis, M. Leounakis, P. Stylianos
*Department of Geology, Dynamic, Tectonic, Applied Geology
Division, University of Athens, GR-157 84 Athens, Greece*

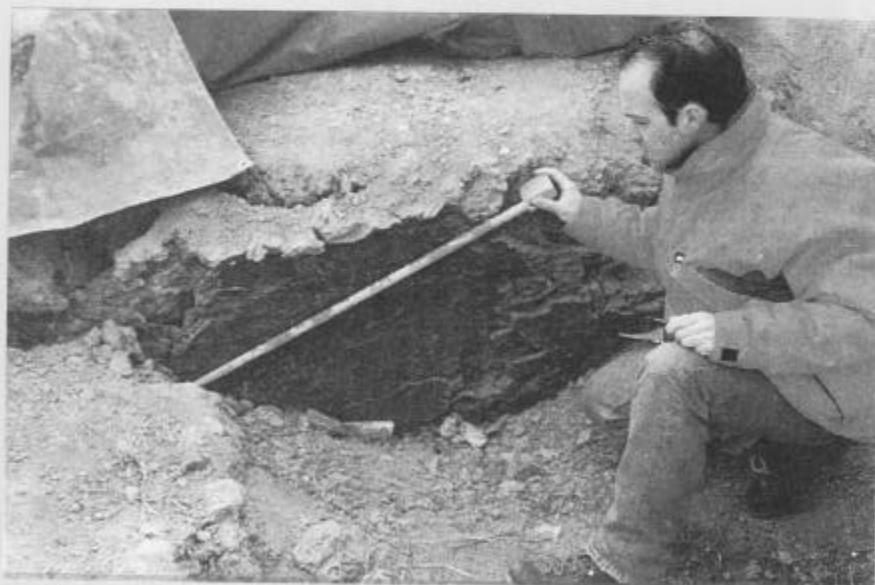
Figure 4: A portion of the surface of the reactivated Nojima Fault showing the relative movement between the fractured blocks.

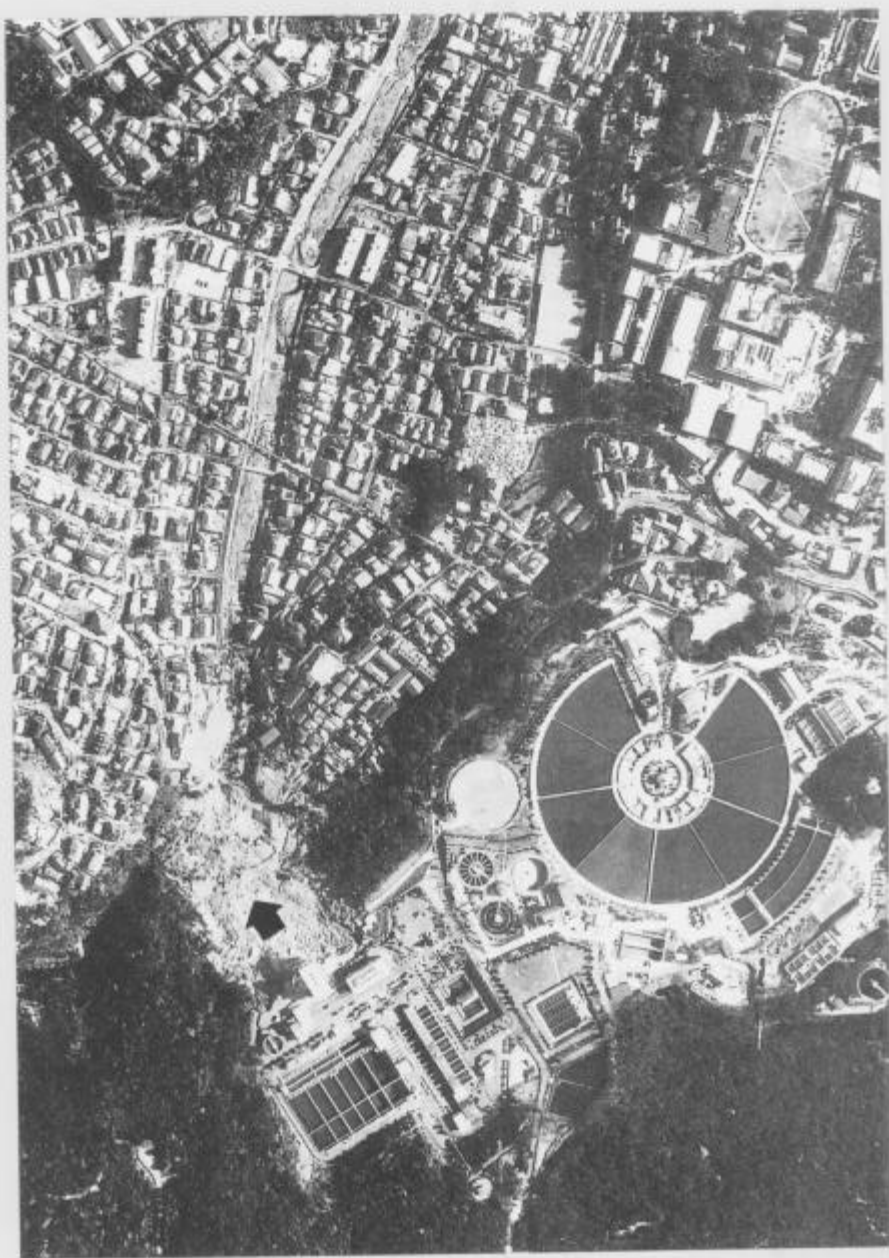
Figure 12: A landslide (marked with arrow) that occurred in the urban area.

On the other hand, the landslides that occurred inside the urban area resulted in the loss of human lives, as well as material damage. (Fig. 12) These landslides were bigger in dimension, up to 100 m. This differentiation is attributed, according to the data collected so far, not only to the proximity of the slide locations with the activated fault zone, but also to the extent of human interventions with the natural environment, that is to say buildings, roads and the formation of artificial slopes.

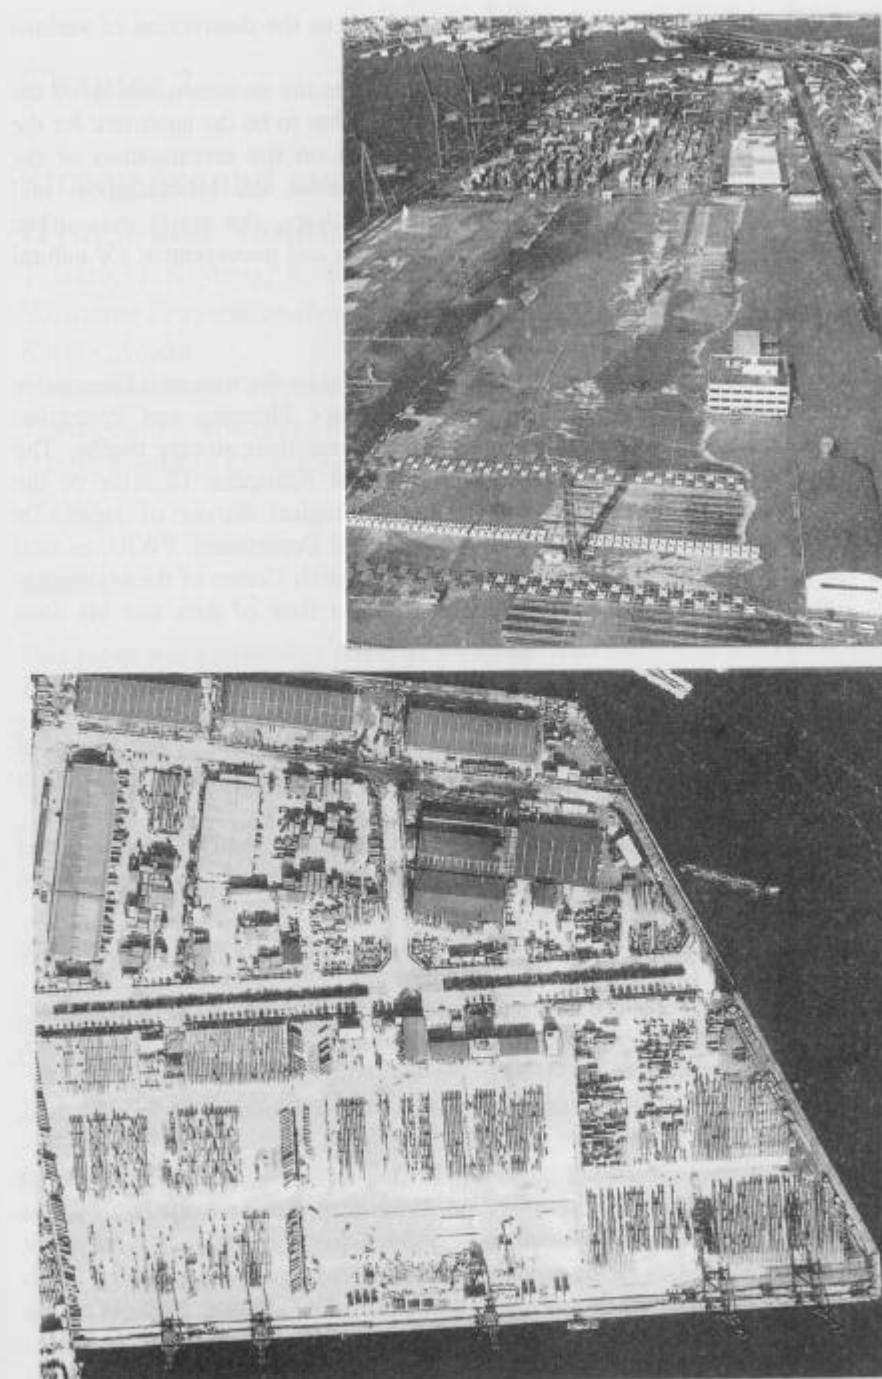
Figure 13: Liquefaction phenomena in reclaimed land areas.

The impact of the liquefaction was particularly grave. The harbour quays and the infrastructure of Kobe Port in general were particularly affected, rendering it useless (Fig. 13). The same was the case for both Rokko Island and Port Island, the reclaimed land islets. Besides, all along the coastal zone, the roads and the surrounding area were affected. However, constructions such as large warehouses, high-rise buildings, liquid-fuel tanks, silos and so forth, remained almost intact due to their foundation in deeper geological formations that were not liquefied during the earthquake.
