**Advances in Earthquake Engineering**

# Earthquake Resistant Engineering Structures

## **The Doppler - Fiseau effect on the damage distribution during the Kobe earthquake (Japan)**

E. Lekkas & H. Kranis

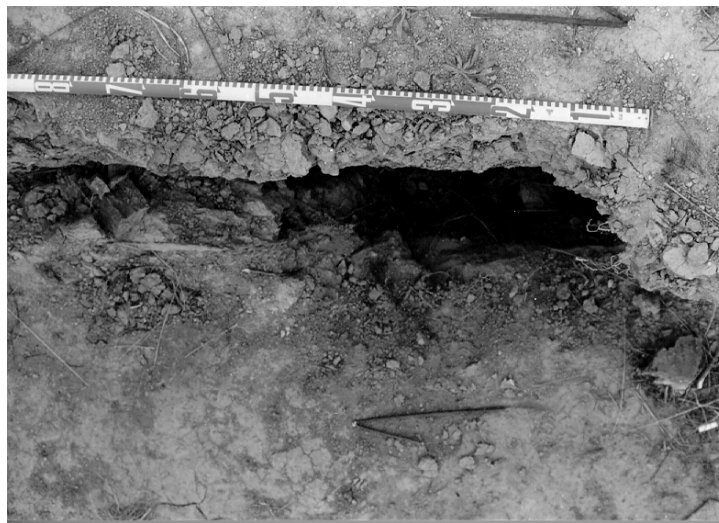
Figure 2. Close-up photo of the reactivated portion of Nojima fault on Awaji island.

tremor was due to the fault that crosses the Akashi Straits, the channel between the city of Kobe and Awaji Island. The result was the reactivation of the Nojima Fault, which actually determines the northwestern coast of the island. This fault strikes  $N40^{\circ}$  -  $N50^{\circ}$  and dips  $75^{\circ}$  -  $80^{\circ}$  towards the NE and had a maximum horizontal offset of 1.7 m. and a maximum vertical slip of 1.3 m.. The survey showed that the fault had been reactivated for a length of approximately 9 km; its continuation in the Akashi Straits, through Plio - Pleistocene and alluvial formations and was planar for sections of up to 200 m in length. Locally, it was in a step-like (en echelon) arrangement, a fact that was in accordance with the dextral-slip sense (Fig. 2) of the seismogenic fault (Lekkas *et al.*, [6]).

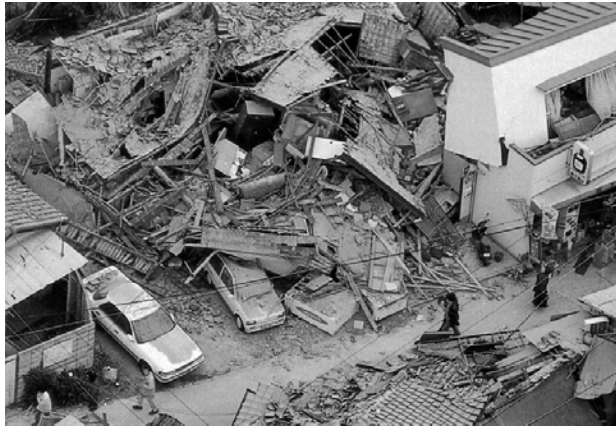
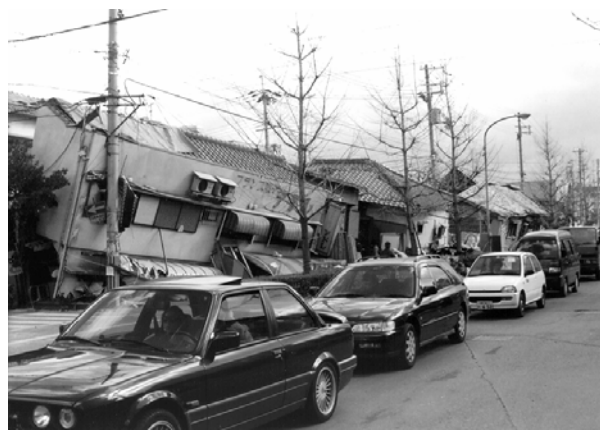
Figure 6. Destroyed wooden houses in Kobe.

Apart from the observation that there was a discrepancy in the maximum intensities between Kobe and Awajishima, there is also another fact that deserves attention, and has to do with the extent and magnitude of damage in buildings of the same type. That is to say, as for the wooden structures (and generally one- or two-storey houses), there was significant differentiation in the destruction: such structures in Kobe collapsed, totally or partially, or suffered severe damage, with only a small percentage suffering light or no damage. According to the official data, 80% of these structures fall into the first category and only 20% in the second. On the other hand, the corresponding percentages were 40% and 60%, respectively (Fig. 6).
