Floods, geodynamic environment and human intervention. The case of Corinth (Greece)

E. Lekkas, S. Lozios, E. Skourtsos & H. Kranis

Dynamic, Tectonic Applied Geology Division, Department of Geology University of Athens, GR-15784 Athens, Greece
Email: elekkas@atlas.uoa.gr

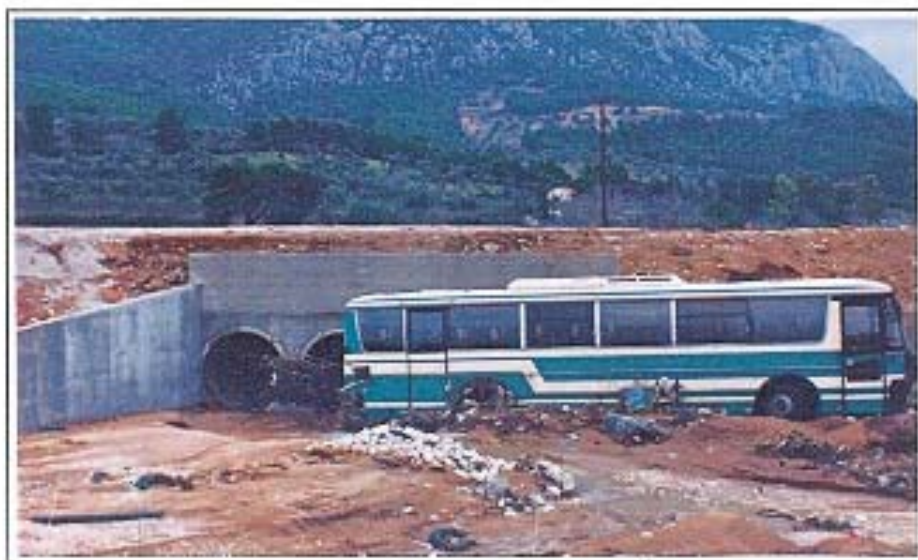
At the confluence of two main streams a new motorway bridge has been built, quite close to the older one. Both of them are made of concrete and have large, round openings that unfortunately proved inadequate to cope with such high precipitation (Fig. 1, damaged site 3). The old bridge was blocked by debris and the new one by a bus that was carried away by the torrential stream (Fig. 2). Vast expanse of vineyards was flooded and the new motorway was destroyed.

Figure 2: Motorway bridge pipes blocked by a bus that was carried away by the torrent.

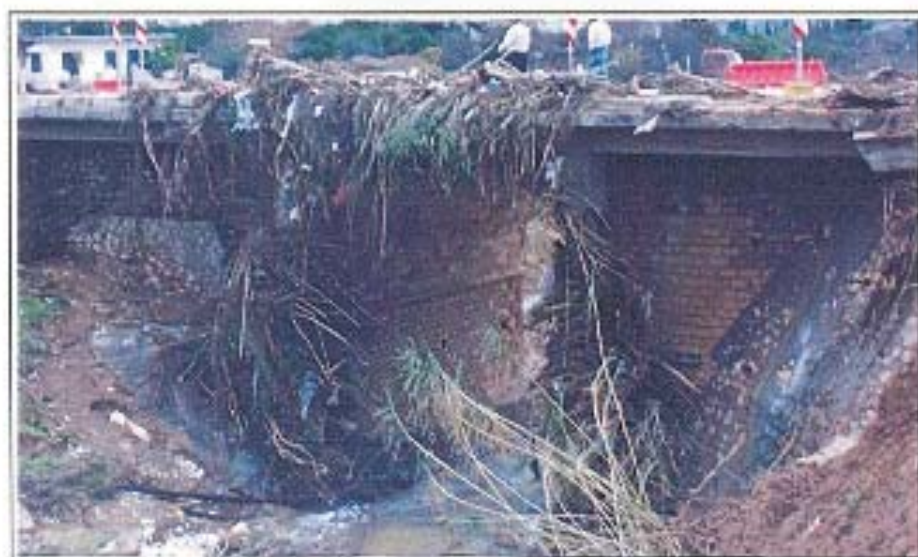
Even the high arch bridge at Solomos did not cope successfully with the torrential flow (Fig. 1, damaged site 6). Despite the fact that the river bed there is incised and deep enough and the arch is about 6m high, 20m wide, large uprooted trees blocked it (Fig. 3) and the water level rose and flooded the nearby houses 2 m above the road surface.

Figure 3: Large uprooted trees blocked the high arch bridge at Solomos village.

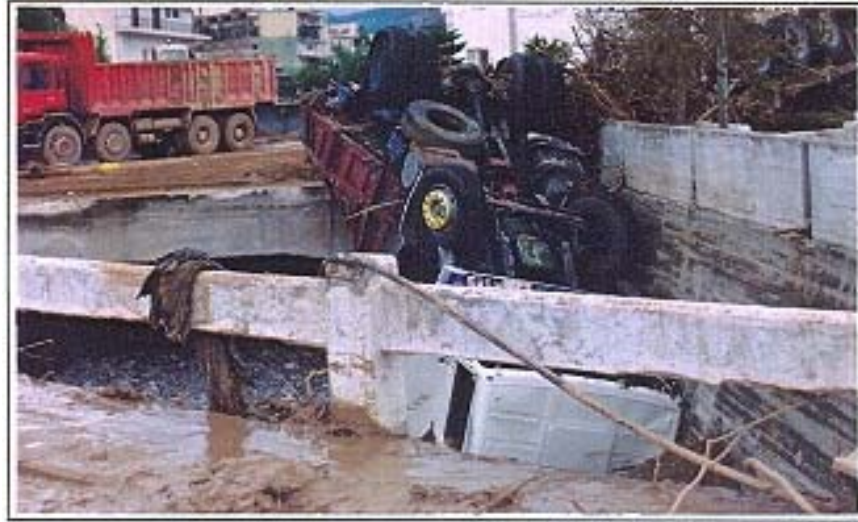
Corinth is built on the delta fan of Xerias. Within the town, the stream bed is artificially incised along the two thirds of its course, in a rectangular cross-section concrete canal, on the upstream end of which exist three concrete bridges, the parapets of which were destroyed and trucks, that were swept off by the torrent, were wedged in between (Fig. 4). The stream, on entering the town, turns 60° eastwards. On this bent an iron low railway bridge was built, and did not withstand the torrential flow. At the turn of the canal the low preventing wall could not hold away the water, which flooded hundreds of houses and swept away tens of cars.

Figure 4: The parapets of the bridge were destroyed and trucks, that were swept off by the torrent, were wedged in between.
