QUANTIFICATION OF HUMAN IMPACT ON NATURAL EVOLUTION PROCESSES AT A COASTAL ZONE, ADJACENT TO AN ACTIVE FAULT

EXTENDED ABSTRACT

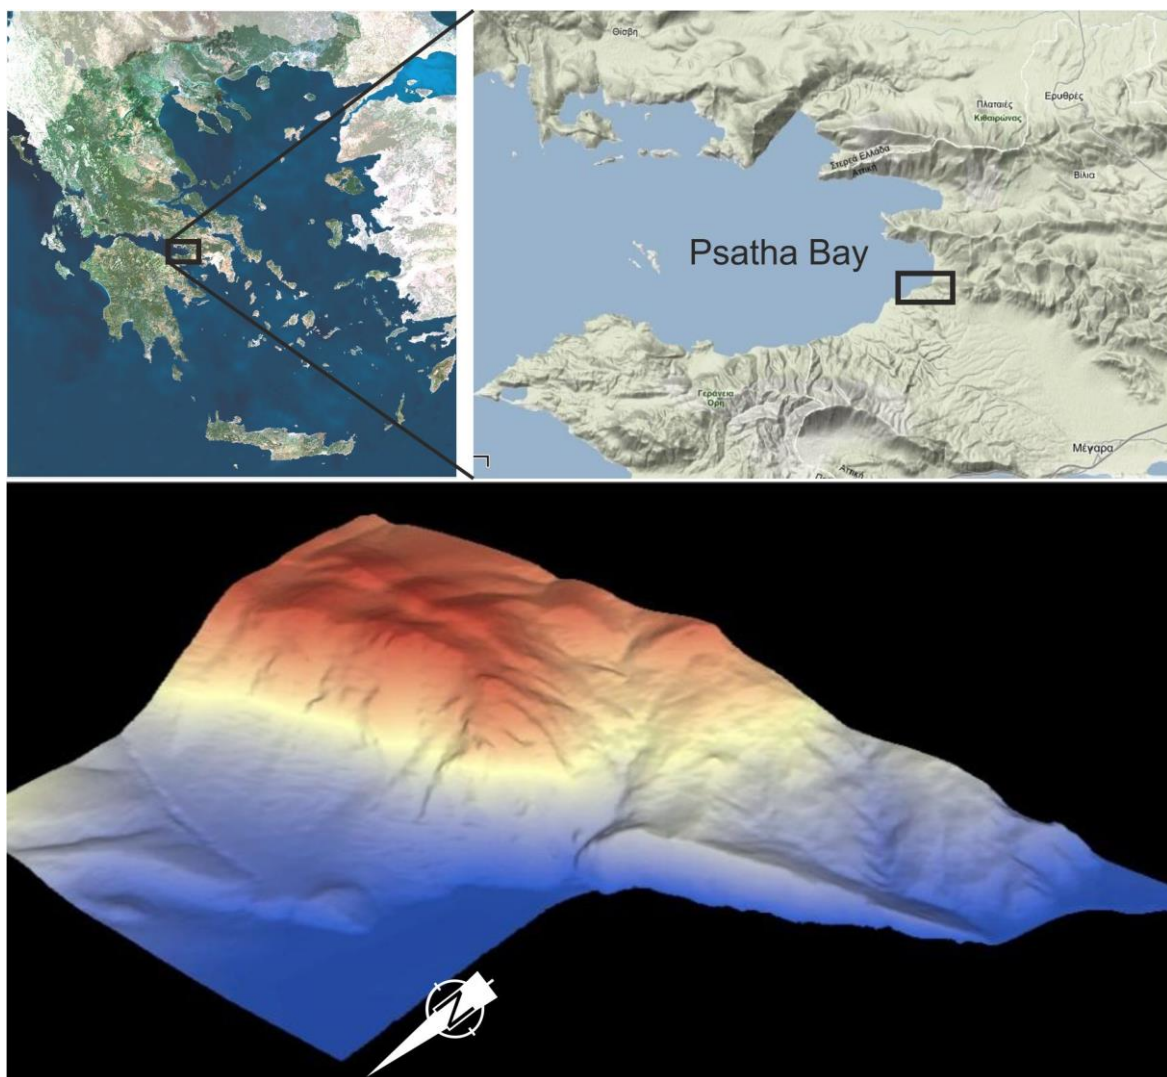
Figure 1. Index map of the study area and high resolution painted shaded relief of the coastal area (below).

The area of interest is located at the easternmost coastal zone of the Corinth Gulf in Greece (see Figure 1). Psatha Bay is one of the most seismogenic regions which hosts

The original data that were used for producing the terrain morphology during the 1970's were analog topographic maps of scale 1:5,000, which were scanned, georectified and the 4m contours were digitized. These maps cover the entire onshore coastal area and a 0.25m spatial resolution digital elevation model was created representing the historic relief (see Figure 1). It was used as a reference dataset on which temporal change

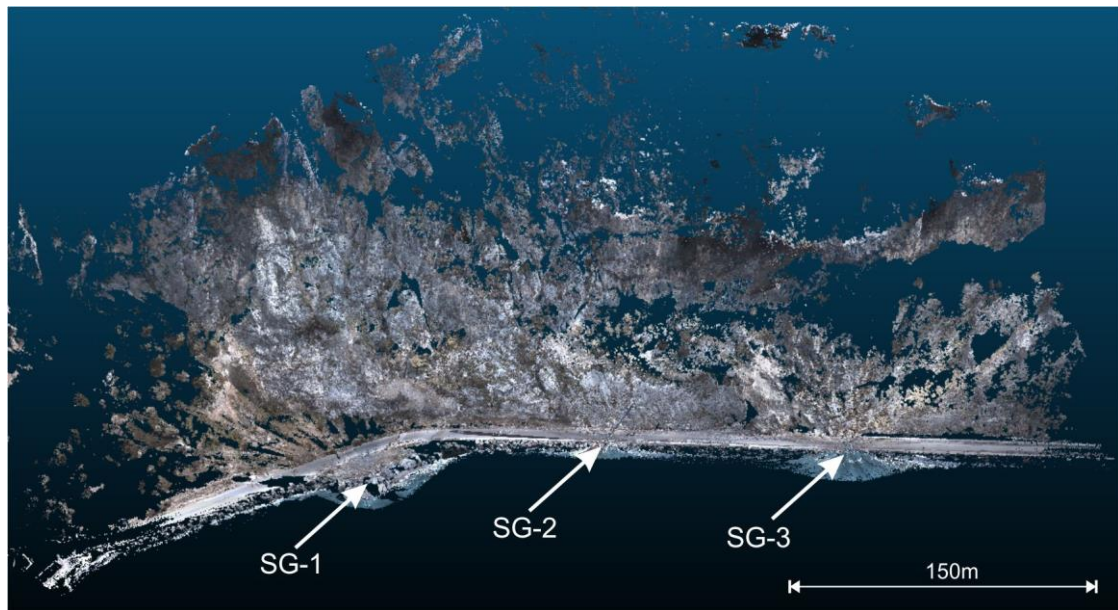
Figure 2. Locations of the local control network stations on a true color 3-D view produced by the point cloud acquired from the ground-based laser scanning.

The SG-1 station was placed on a large limestone block which was naturally fallen on the beach area, in order to have good visibility at the debris outcrop, whilst the next two (SG-2 and SG-3) were placed on the sidewalk along the road next to the coastline. The latter were placed opposite from the vertical cliffs, which have been formed by the fault activity, in order to acquire the largest possible relief information of the fault surface during the laser scanning (Abellan *et al.*, 2006, Buckley *et al.*, 2008, Lato *et al.*, 2012). Finally, the surveying methodology was completed by laser scanning of the onshore coastal area. A terrestrial laser scanner was used (Leica ScanStation C-10) and placed on the three established stations (see Figure 3a). Three point clouds with 2-5cm measurement spacing and $\pm 6\text{mm}$ precision were merged in a single point cloud covering the entire coastal area and minimizing the shadow effect due to the roughness of the cliff (Wiatr *et*

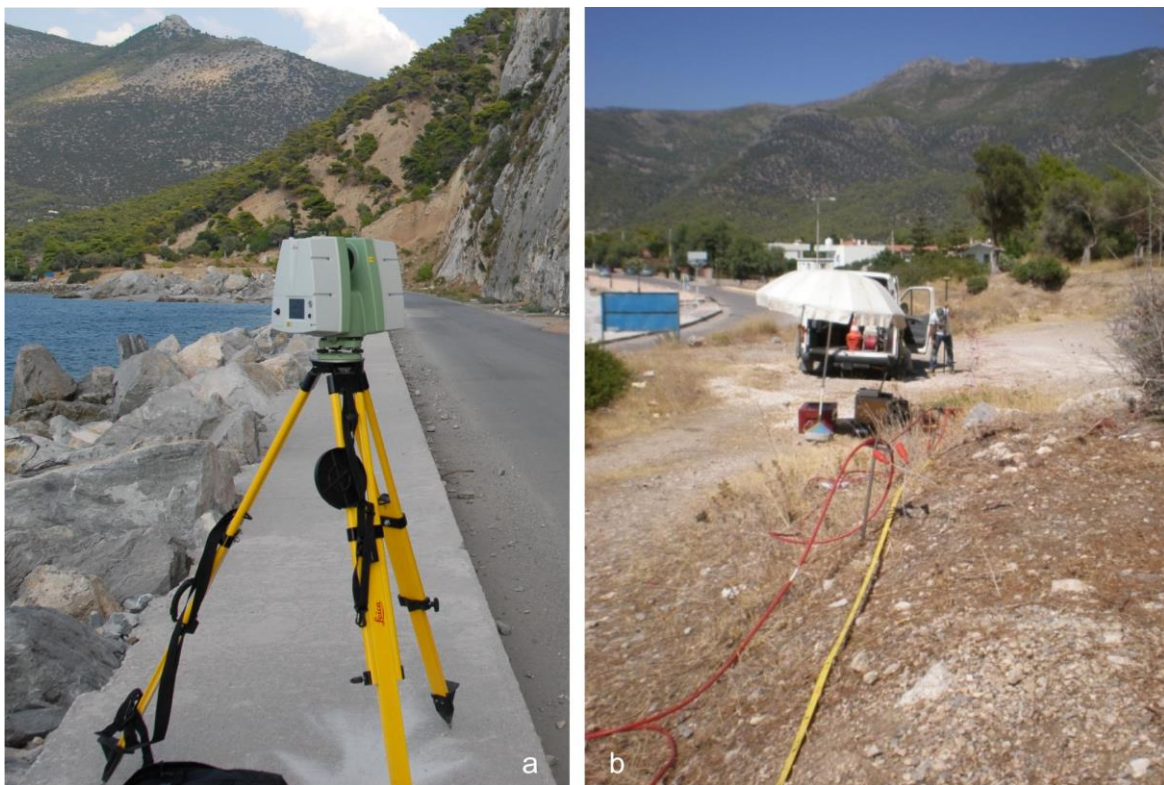
Figure 3. Field work data acquisition by surveying with the terrestrial laser scanner at the station SG-2 (a) and geophysical tomography along the ERT-1 section (b).

surveying in the wider area of debris outcrop, northeast of the fault, geophysical surveys were also carried out in order to investigate the subsurface structure (see Figure 3b). The technique of geoelectrical tomography (Electrical Resistivity Tomography) was applied, with the execution of totally four (4) geoelectrical sections covering all the accessible extent of the debris in the proximal region of the fault trace along the coastal zone (see Figure 4).

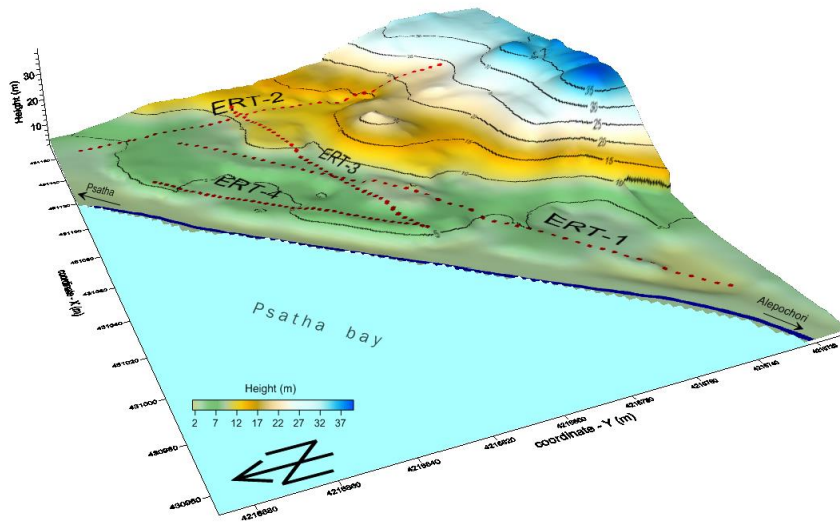
Figure 4. Geophysical sections on a topographic relief of the area.

all geoelectrical-geological sections, the sea level is depicted with a dashed line (see Figure 6 & 7). In sections ERT-1 (see Figure 6) and ERT-3 (see Figure 7), that were developed close to the coast line of Psatha bay (see Figure 4), even up to the altitude of the sea, an almost horizontal resistive geoelectrical layer of 200-3500 Ohm.m corresponds to unsaturated and slightly welded debris was investigated, while the underlying conductive geoelectrical formation of 5-200 Ohm.m relates to saturated debris.

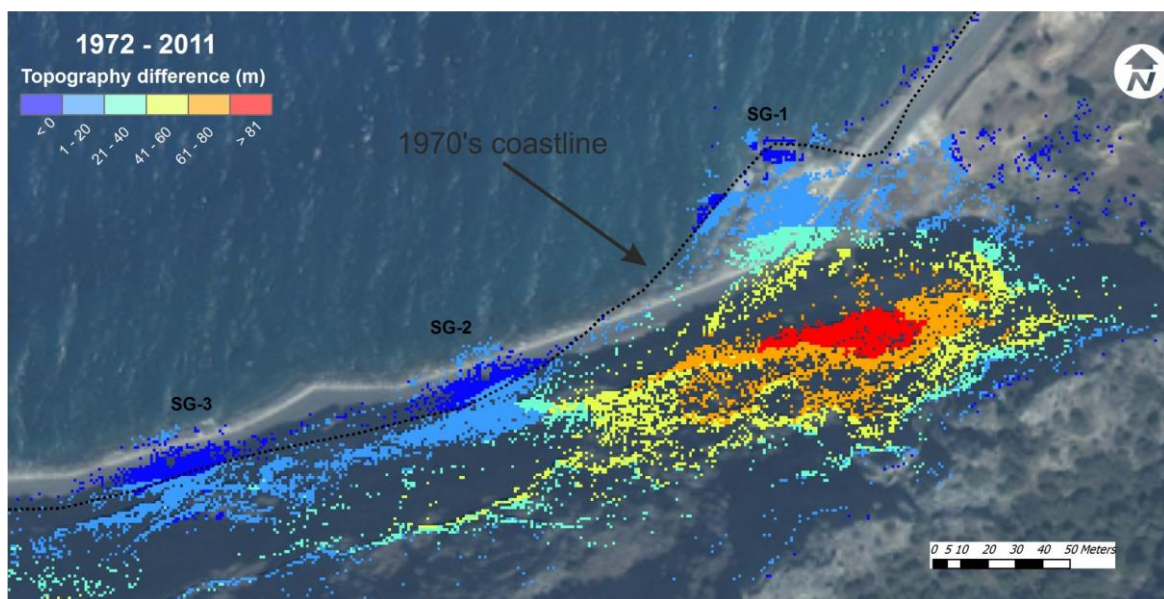
Figure 5. Surface changes along the coastline for the period 1972-2011. The alteration of the coastal zone during the 40 year period is clear as well as the impressive decrease of the volume of the debris next to the fault scarp.

The two DEMs were co-registered and subtracted by using raster calculations in a Geographic Information System (ArcGIS v.10) and the resulted image was draped over a recently acquired pansharpended orthorectified IKONOS-2 satellite image (1m spatial resolution) for further interpretation (see Figure 5). The changes along the coastal zone were impressive as the road along the shoreline was constructed after the production of the historic maps, as well as the on shore section of the coast suffered severe alteration by erosion and human interference. It seems that the most of the debris were removed from the hanging wall, which was used as an improvised quarry for building material. The overall elevation change was quantified and at certain areas the total soil loss exceeded the 80 meters.

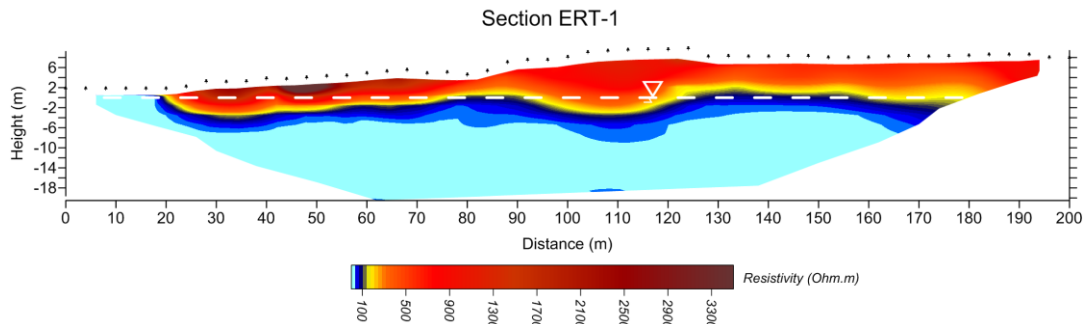
Figure 6. ERT -1 with topographic relief (5th iter., RMS 4.37%).

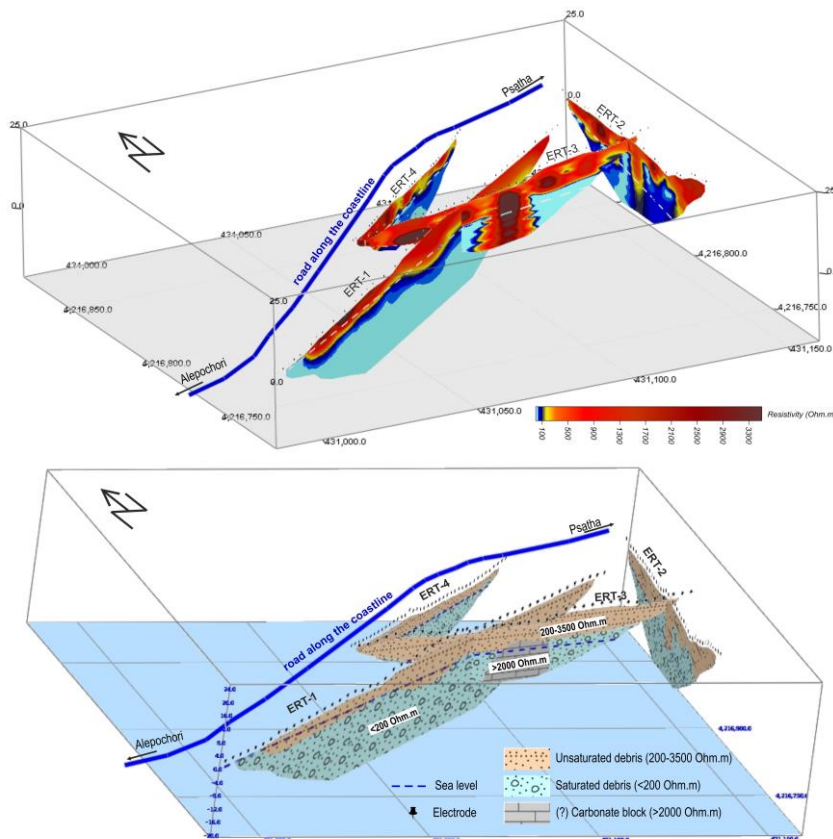
Figure 7. 3D illustration of the geoelectrical sections results evaluation.

For a realistic illustration of the evaluation of the geophysical results and of the imprint of subsurface structure, a three-dimensional illustration was constructed (see Figure 7). At

A particular feature in the geoelectrical-geological section ERT-3 (see Figure 7) was identified in the middle (60m) and for approximately 20m range. It was a highly resistive structure (> 2000 Ohm.m), which appears to be continued below the sea level. This geoelectrical formation is attributed either to the existence of a 'buried' carbonate block fallen from the foot wall, or to a powerful welded debris with calcite carbonate material. In either case it is more than a proof that material of various sizes keeps falling for a long time period at this zone.

Similar subsurface general conditions of ERT-1 and ERT-3, seems to exist in geoelectrical-geological section ERT-4 (see Figure 7). The geoelectrical section ERT-2 was developed in S-N direction, at the easternmost accessible region of debris. The underlying conductive geoelectrical formation (<200 Ohm.m) that was investigated at an altitude of 8-10m, was attributed to an underground aquifer, the existence of which seems to be associated with distinct ground water flow from the upstream adjacent Neogene and Quaternary sediments.
