# FRACTURE PATTERN DESCRIPTION AND ANALYSIS OF THE HARD ROCK HYDROGEOLOGICAL ENVIRONMENT, IN A SELECTED STUDY AREA IN TINOS ISLAND, HELLAS

K. BOTSIALAS<sup>1</sup>, Emm. VASSILAKIS<sup>2</sup>, G. STOURNARAS<sup>3</sup>

National and Kapodistrian University of Athens, Greece  
Faculty of Geology, Department of Dynamic, Tectonic & Applied Geology

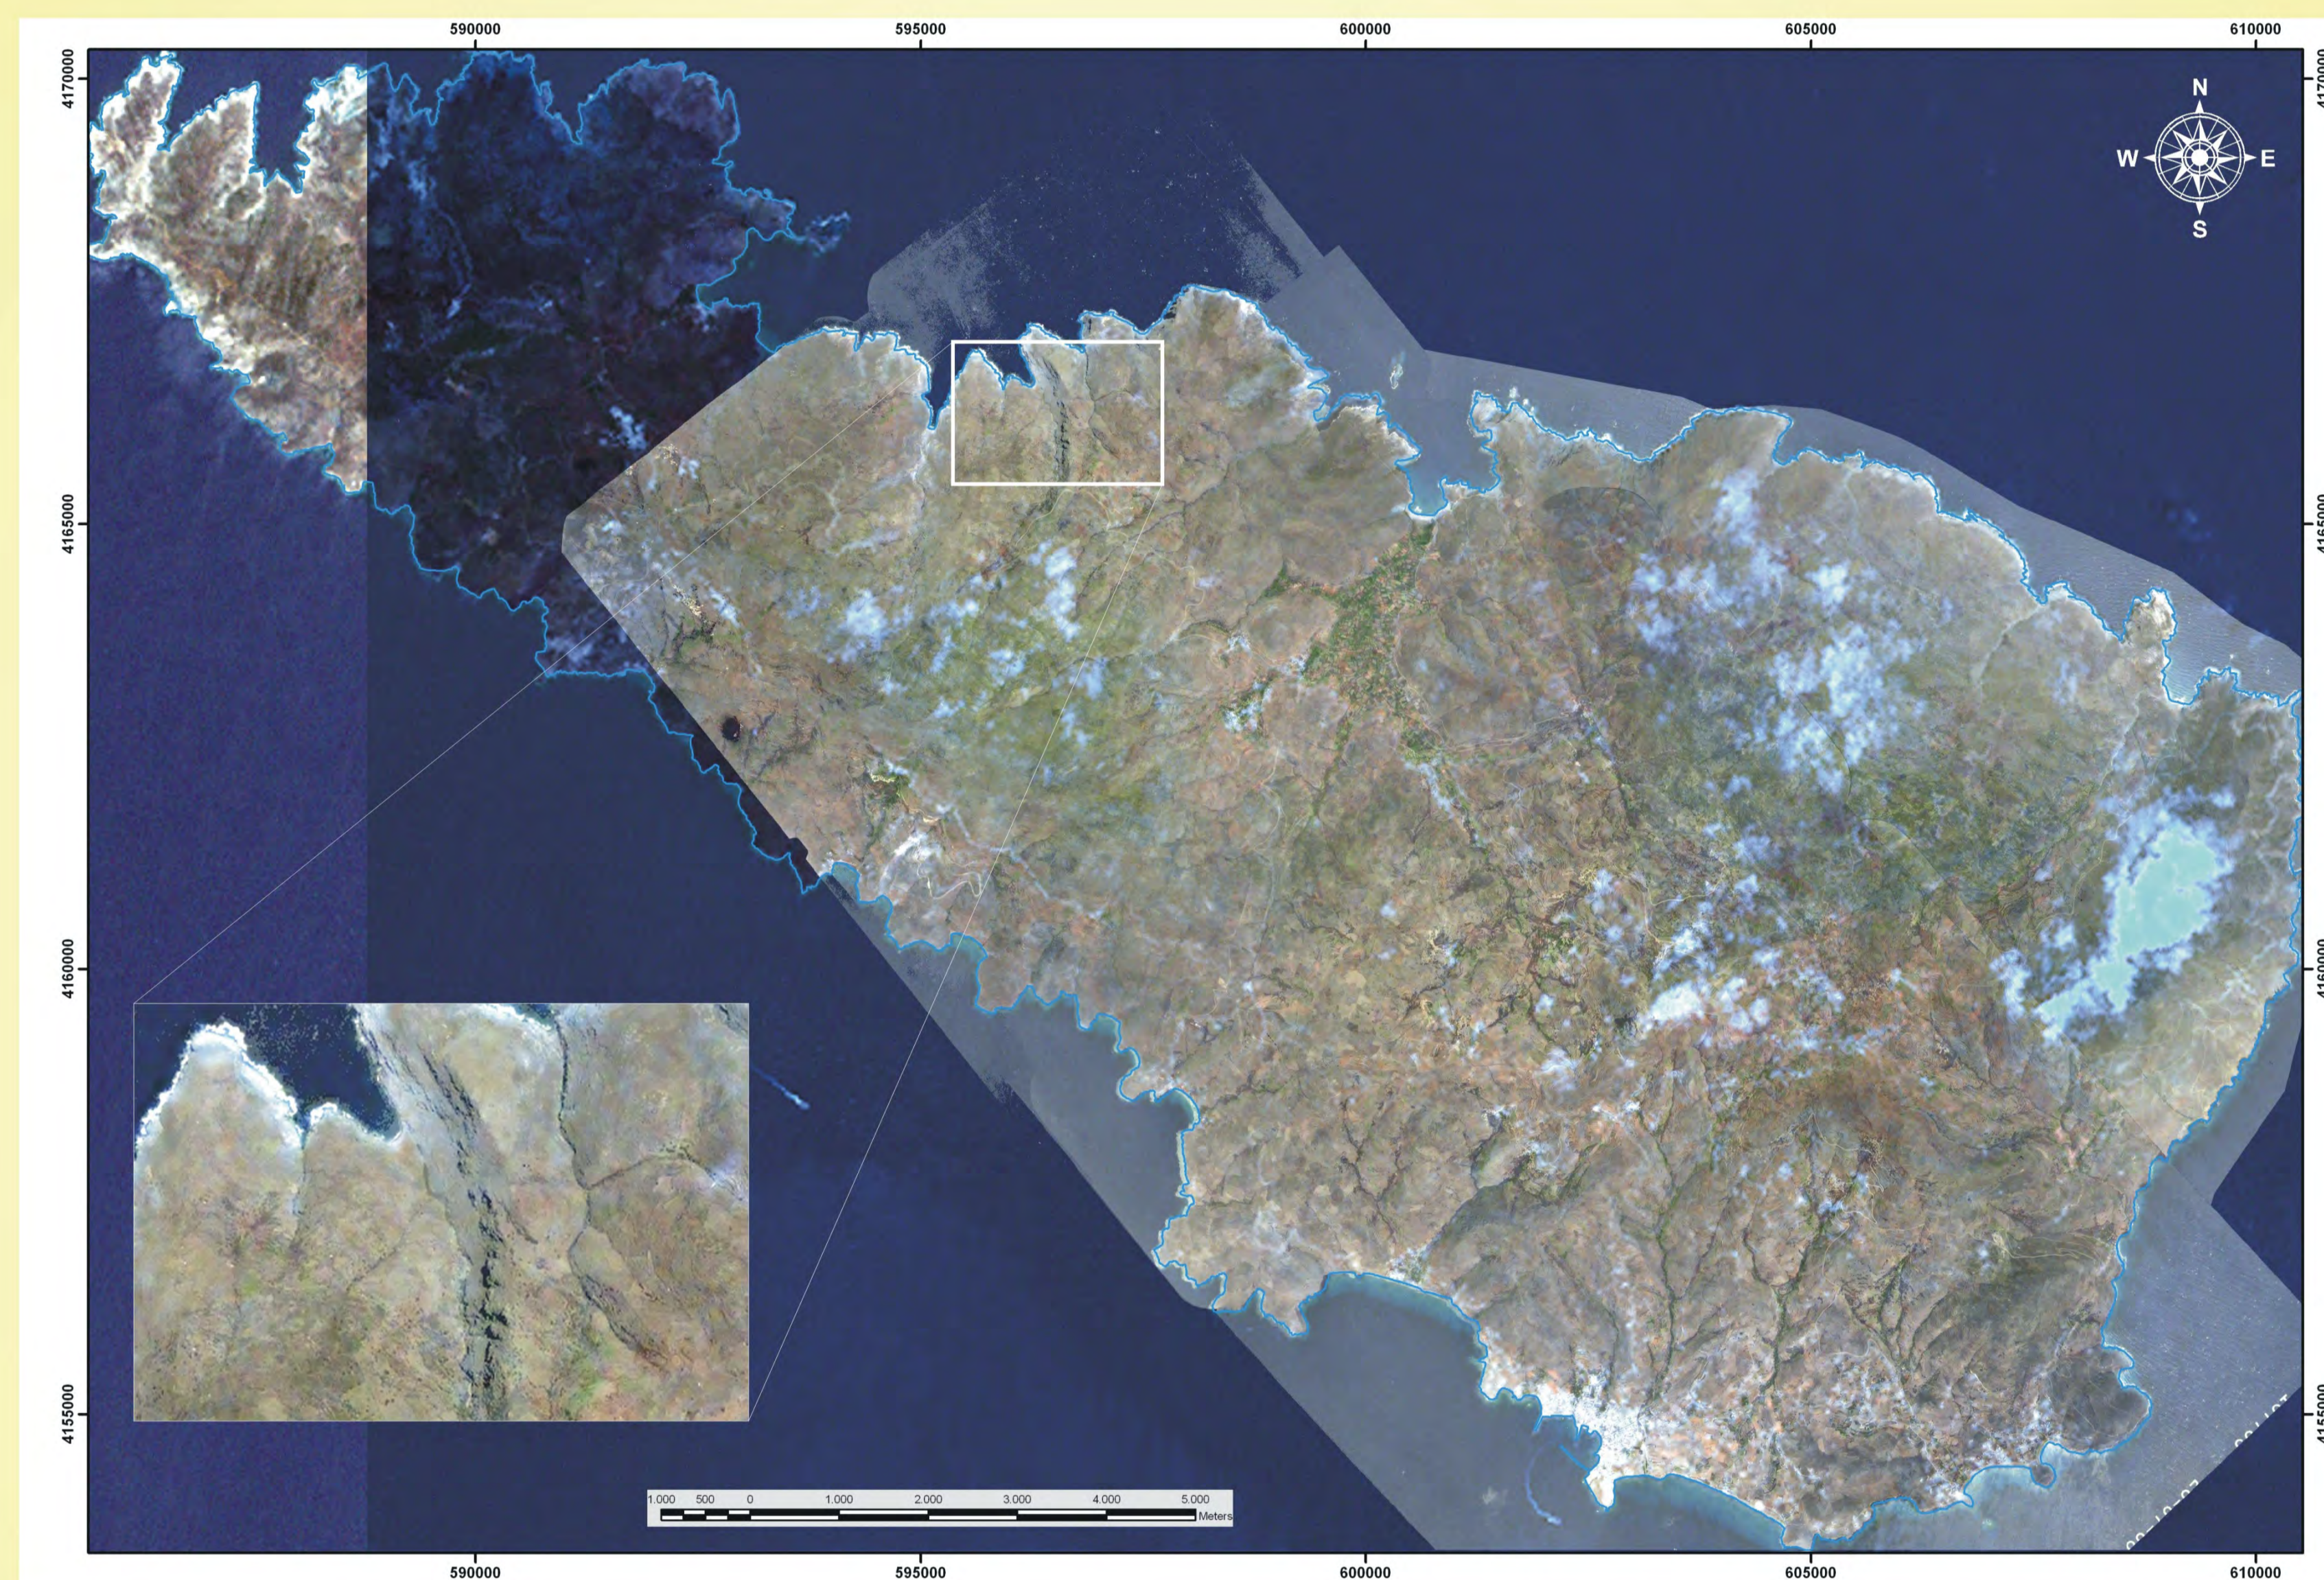
A dataset of Landsat 7 - ETM+ was subset and a combined satellite image of Tinos Island was produced with a resolution of 15m per pixel and 8 available spectral bands to combine. In order to reach the best possible accuracy, the georeferenced images were orthorectified using a digital elevation model with a cell size of 10m and finally projected on the Hellenic Geodetic Reference System (HGRS'87). The orthorectified image was used in order to identify lineaments that could correspond to tectonic structures which might be supplementary to previous researchers' mapping work. Consequently a set of air photographs (1/30.000 scale) was also orthorectified at the same projection

and an orthophoto mosaic was produced reaching a high resolution of 5 meters per pixel. Following, the high and relatively low resolution images were merged using the principal component method, in order to produce a higher resolution digital set of 8 bands. This image has the same spectral characteristics of Landsat 7, but also better resolution. The figure above shows the extracted detail of the interpreted image. This new image was used for lineament interpretation (at larger scales) as these could be related to zones of deformation and fracturing, which implies zones of higher secondary porosity.

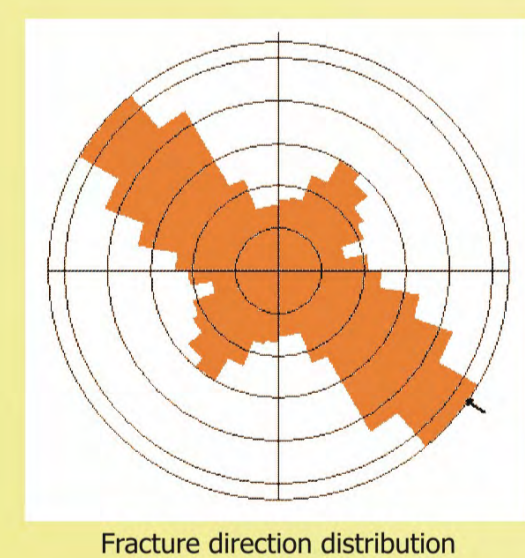
Fracture direction distribution

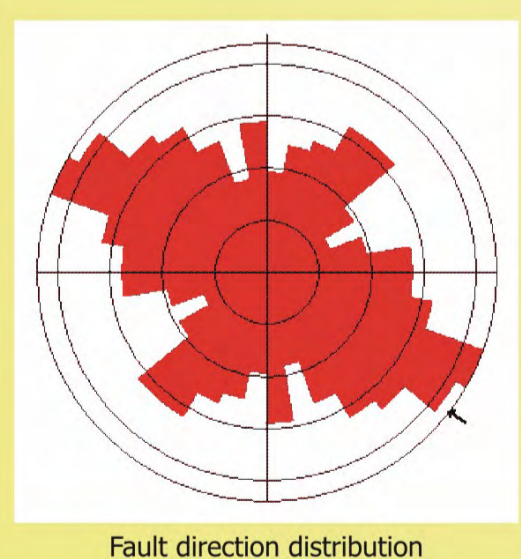
Fault direction distribution

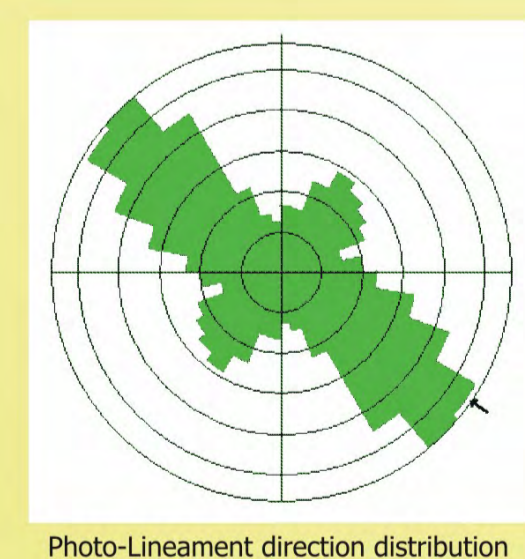
Photo-Lineament direction distribution
