# Liquefaction, ground fissures and coastline change during the Egio earthquake (15 June 1995; Central-Western Greece)

E. Lekkas\*, S. Lozios, E. Skourtsos and H. Kranis Department of Geology, University of Athens, GR 157 84 Athens, Greece

Terra Nova, 8, 648-654, 1996.

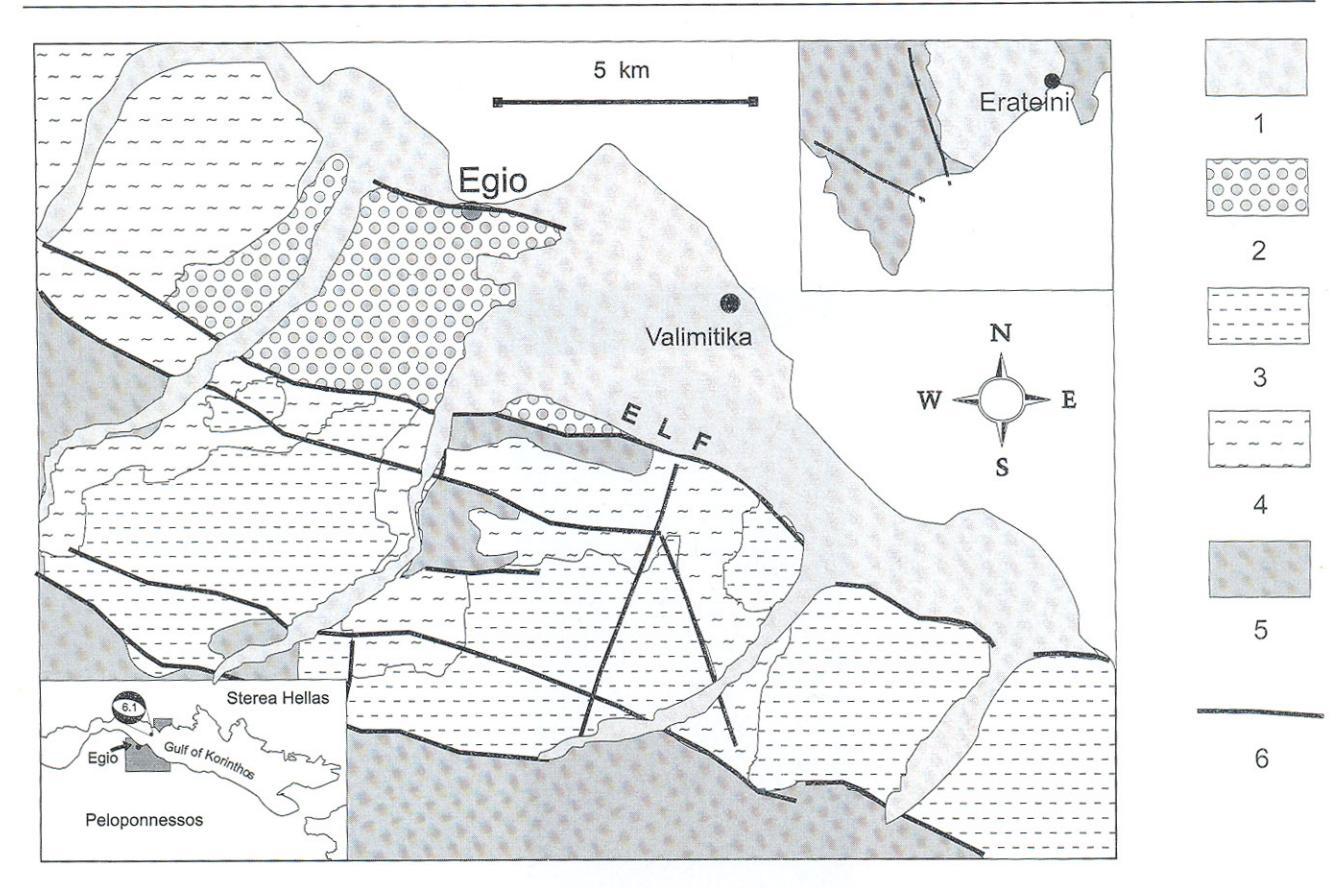
Fig. 1. Modified geological sketch map after Poulimenos et al., (1993). 1. Alluvial coastal and fan delta deposits (Holocene), 2. M. Pleistocene-Holocene alluvial fan deposits, 3. M. Pleistocene fan delta deposits, 4. L. Pleistocene lacustrine–laggonal deposits, 5. Alpine basement, 6. Faults and fault zones. ELF:Eliki Fault.

The study area belongs in the neotectonic macrostructure of the Gulf of Korinthos, which separates Peloponnessos from mainland Greece (Fig. 1). Its western extremity lies next to the Hellenic Trench and its eastern end is near the volcanic arc.

which are of listric character with NNEdipping fault surfaces (Doutsos and Piper, 1990). A good example of such faults is the Eliki fault (ELF in Fig. 1) that strikes ESE-WSW and has created a distinct scarp, visible for 2 km south of Egio. The footwall of ELF consists of Pleistocene sediments overlying the alpine bedrock, while its hanging wall comprises Holocene fan deposits. Its vertical throw has been estimated at 450 m and has had an average uplift movement rate of 0.25 mm yr<sup>-1</sup> (Doutsos and Poulimenos, 1992). Although this fault is thought to have been reactivated in the 1861 earthquake (Schmidt, 1875), it remained inactive during the 15 June 1995 shock.

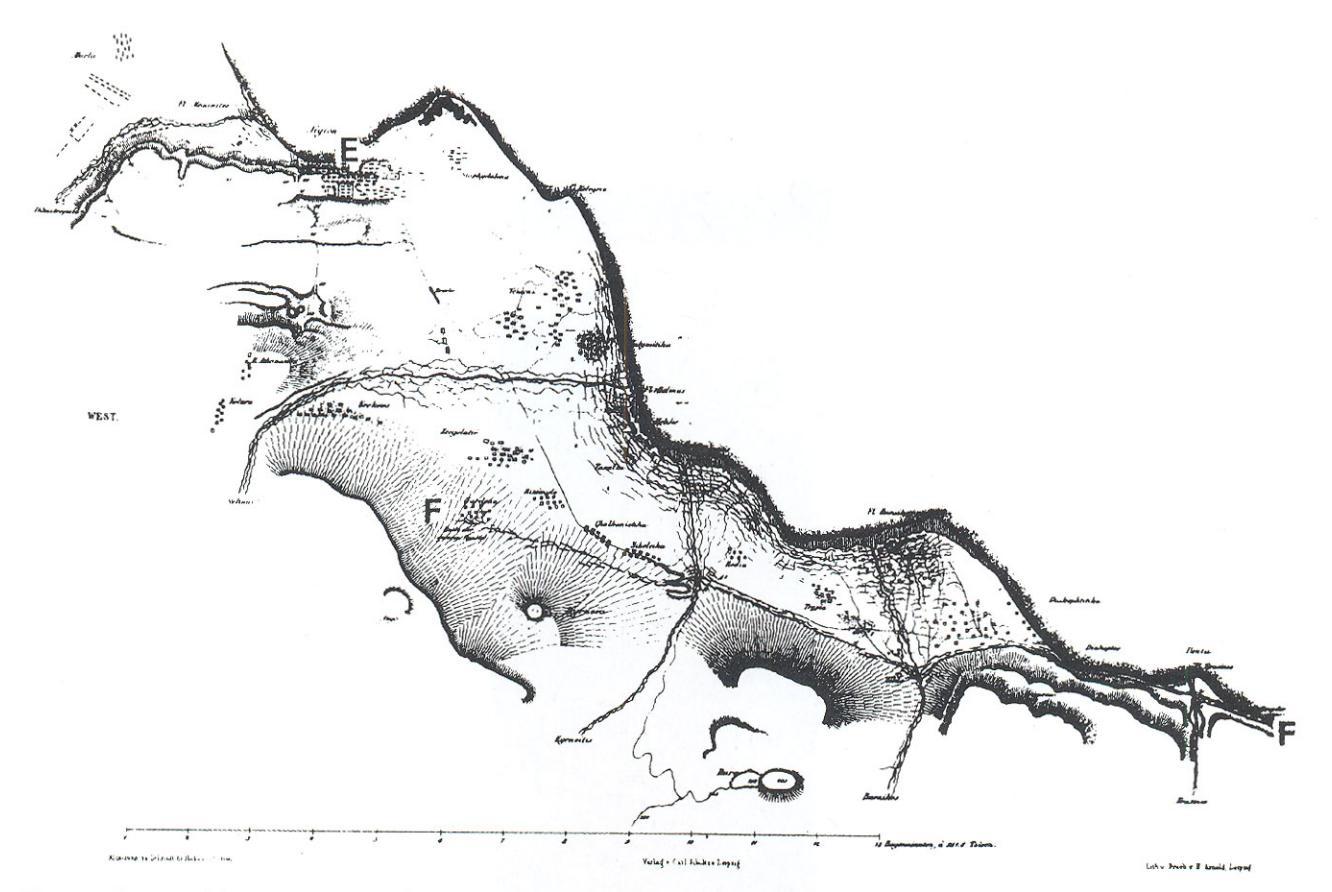
Fig. 2. The map of the concomitant to the 1861 earthquake phenomena, after Mougiaris et al., 1992 reporting Schmidt, 1875. FF: the postulated fault break; E: Egio.

Finally, as for the earthquake that hit Egio in 1861, there are not only written reports on the destruction, but also comprehensive mapping of the earthquake-related surficial effects, by Schmidt (1875) (Fig. 2). In that map, ESE-WNW trending fractures have been depicted, coinciding possibly with the trace of the Eliki fault zone (Mougiaris et al., 1992). Schmidt's study confirms the seismogenic reactivation of the fault zone during that event (Figs 1, 2). Furthermore, coastline change, ground fissuring and liquefaction took place. The phenomena that occurred in the 1861 earthquake were located at the same zones as observed in the 1995 earthquake (Figs 2,3).

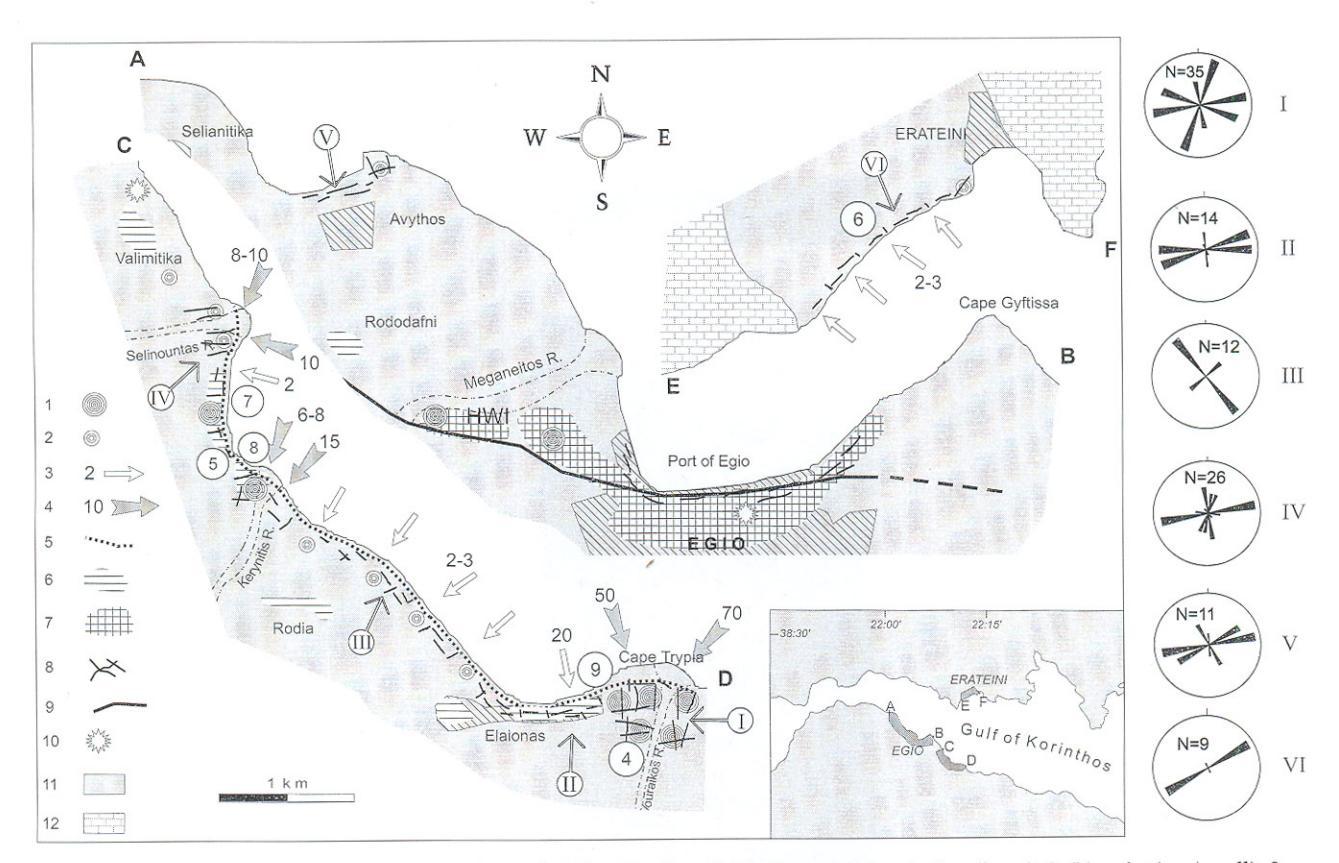
**Fig. 3.** Regional map with the occurrences of the earthquake-related surficial effects. 1. Liquefaction (large), 2. Liquefaction (small), 3. coastline retreat (small magnitude) and retreat estimate, 4. coastline retreat (large magnitude) and retreat estimate in metres, 5. postearthquake shoreline, 6. minor damage areas, 7. major damage areas, 8. ground fissures, 9. earthquake fracture, 10. building collapse, 11. post-Alpine sediments, 12. Alpine basement. HWI: Hellenic Weapon Industry. Latin numerals denote the locations of the rose diagrams of fissures. Numbers in circles indicate approximate locations of figures 4–9.

Soon after the 15 June 1995, earthquake detailed recording and analysis of observed surficial phenomena (namely liquefaction, ground fissures and coastline changes) was carried out (Fig. 3). These effects were located within a 2-km-wide zone along the northern coast of Peloponnessos. This zone extends from Selianitika and Cape Trypia, to the west and east of Egio, respectively. However, at the southern coast of Sterea Hellas comparable phenomena were limited to a 50 m by 1 km-wide zone at Erateini.

The fissures at northern Peloponnessos were located along an 8km long coastal zone, between the mouths of rivers Selinountas and Vouraikos, along the coast between river Meganeitos and Cape Gyftissa, and along the coast of Avythos, at the west of Egio (Fig. 3). At the opposite coast of southern Sterea Hellas, fissuring was limited to a few surface cracks in thin, localized outcrops of coastal and fluvial deltaic deposits at Erateini (Fig. 6); these fissures did not propagate into the Alpine basement.

The liquefaction occurred in zones along the coastal area of Egio, and for a width of 400 m, while there were additional liquefaction sites located inland, on terraces 20–100 m high. Liquefaction occurred primarily in the area between the mouths of Selinountas river and Cape Trypia, where Vouraikos discharges, and the coastal zone to the west of Egio (Avythos). In places, too, liquefaction occurred in association with earthquake fractures, as for example at the premises of the Hellenic weapon industry (HWI in Fig. 3). The total liquefaction area amounts to 1 km<sup>2</sup>.

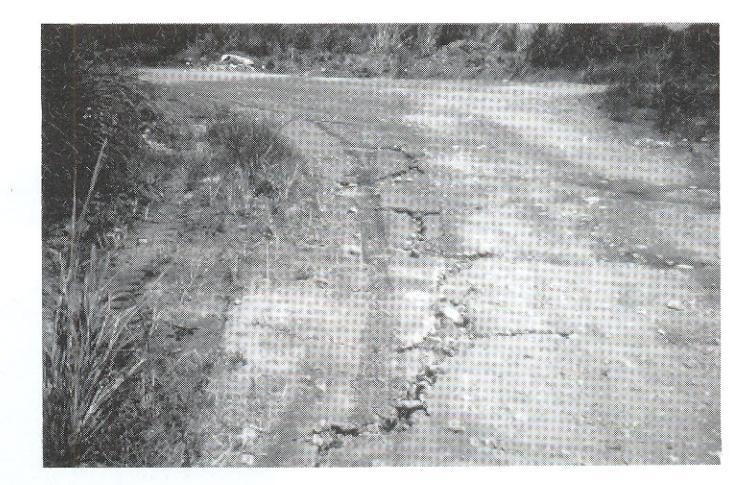
**Fig. 4.** *Ground fissures along the road, to the east of Egio. The prevailing trends are directly related to the direction of the nearby river bed of Vouraikos.*

The length of fissures varied from a few tens of cm to some tens of m. The cracks were mostly linear, slightly divergent or curved and in some cases *en échelon* arranged. Their width was from a few mm to 40 cm and their visible depth reached 60 cm. In some cases the depth must have been greater, but the open cracks were filled with rubble from the collapsed walls, or with emergent liquefied material. In certain fissures, or segments of them, a minor vertical offset was observed, accompanied by a small dextral or sinistral offset, of few mm or cm.

Systematic study of the trends of the fissures at Egio showed that there were two prevailing sets, one parallel to the coast and one normal to it. Besides, at the cracks located in the river deposits and along the levees, the pattern was similar; however, in this case, the primary set ran parallel to the river bed and the secondary normal to it. No definite geometrical pattern occurred amongst the fissures in the deltaic deposits, but it was relevant either to the one along the coast or at the riversides. In contrast, fissures at Erateini run almost exclusively parallel to the seashore.

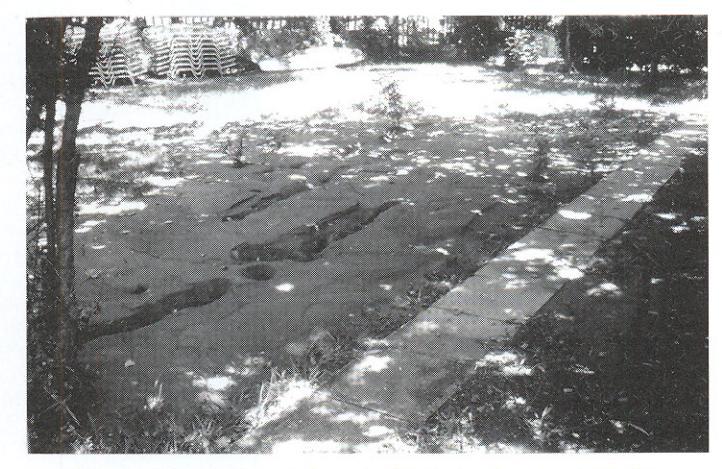
Fig. 5. Liquefaction at the east of Egio, inside a tourist facility.

(10<sup>3</sup> m<sup>2</sup>) were covered by the emergent quicksand, causing considerable damage to open recreational spaces, roads, crops, pumping wells and tourist facilities (Fig. 5).

The field study confirmed that liquefaction took place at areas consisting of recent formations of coastal, alluvial and fluvial deposits. Quicksand was ejected through: (i) craters, measuring less than 30 cm in diameter, lying along fissures; (ii) craters that lay on the intersection between two or more fissures (their diameter in these cases was up to 50 cm); (iii) the fissures (or parts of them), creating sand ridges, and more scarcely; and (iv) isolated craters up to 50 cm in diameter. It was also reported by farmers that boreholes served as funnels for the upward movement of the guicksand. Mainly fine material (sand and silt) was ejected and more rarely coarser material (fine gravel). In other cases no surficial outflow was noticed, but the liquefied material caused loss of support of the overlying formations which in turn were

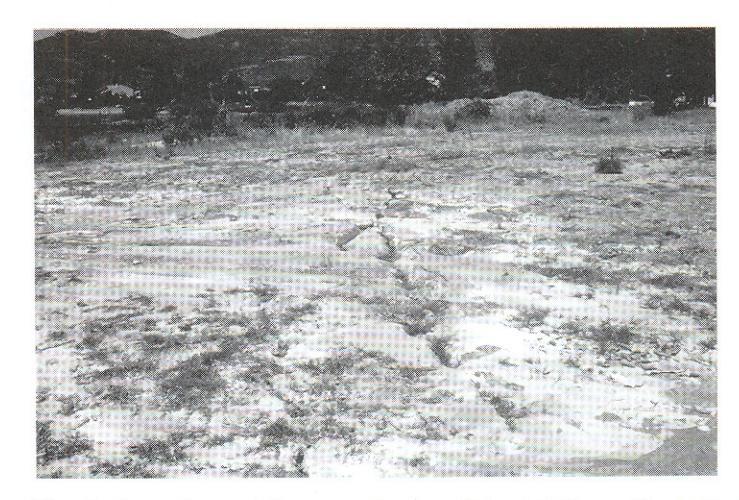
**Fig. 6.** *Liquefaction and ground fissures at the coast of Erateini. The aquifer at this site was saline, a fact that led to the deposition of thin salt layers (after the evaporation) together with the quicksand.*

In contrast, liquefaction was more limited at the northern coast of the Gulf, at Erateini (Fig. 6). The total area of liquefaction here did not exceed 0.5 km<sup>2</sup>.

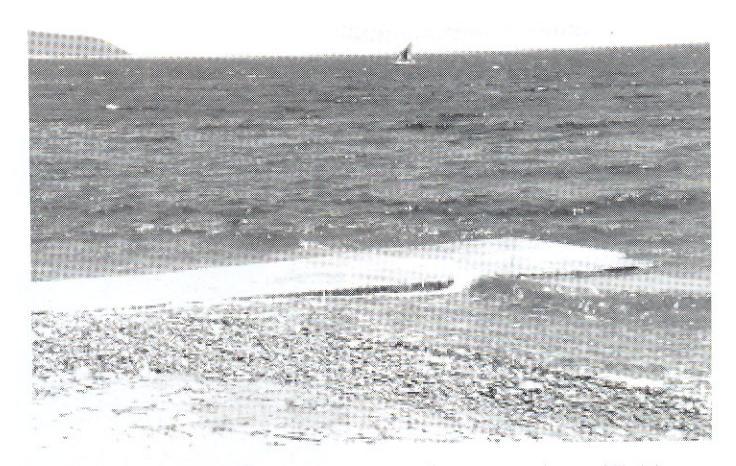
Fig. 7. Submerged jetty due to coastline retreat (east of Egio).

The shock was accompanied by intense coastline change, with significant coastal retreat in the coastal area between the mouths of rivers Selinountas and Vouraikos, and at the coast of Erateini, causing damage to a few minor harbour constructions, tourist facilities and roads (Figs 7, 8).

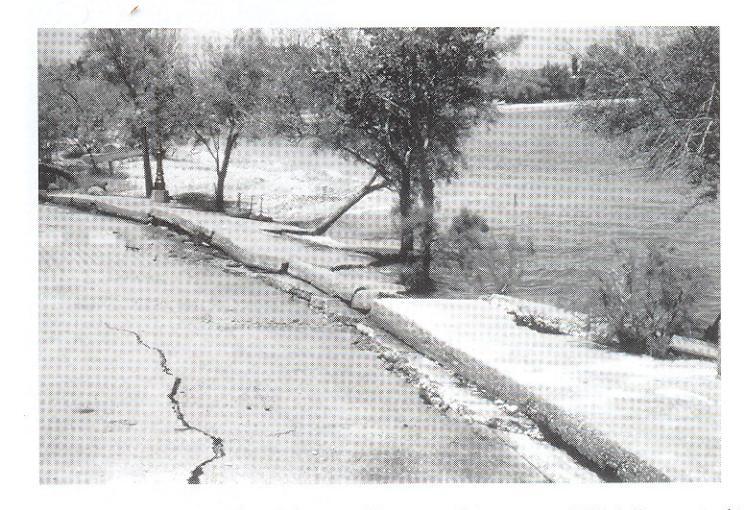
Fig. 8. Damage at a seaside road, caused by coastline retreat (Nikoleika, east of Egio).

The extent of coastline retreat varied throughout the zone. Thus, at Nikoleika (Fig. 8) the sea advanced a few metres, while at the delta of Vouraikos this same change was up to some tens of metres. The most impressive change took place at the coast east of Eleonas, up to Cape Trypia, where the recent deltaic deposits of Vouraikos river and coastal deposits occur. At this place, the sea advanced inland for about 50 m at the east of the hamlet and the total width of the land inundated by the sea is more than 70 m at Cape Trypia (Fig. 9). As a result, large parts of the shore do not exist any more. This change gradually becomes smaller heading to the west of Eleonas, being less than 10 m at the mouth of Selinountas, and finally becoming negligible at Valimitika.

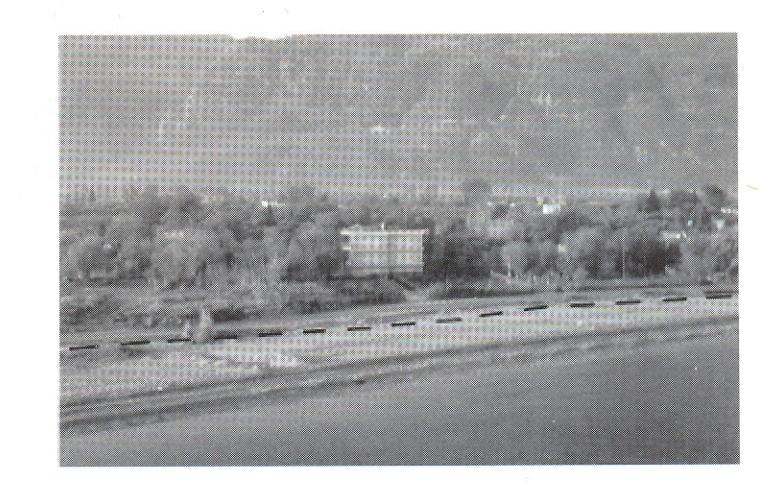
**Fig. 9.** Photograph taken a few days before the June 15 earthquake, at Elaionas, east of Egio. The dashed line shows the post-earthquake shoreline. The retreat is as much as 50 m.
